STRUCTURAL APPRAISAL

Bramcote Leisure Centre

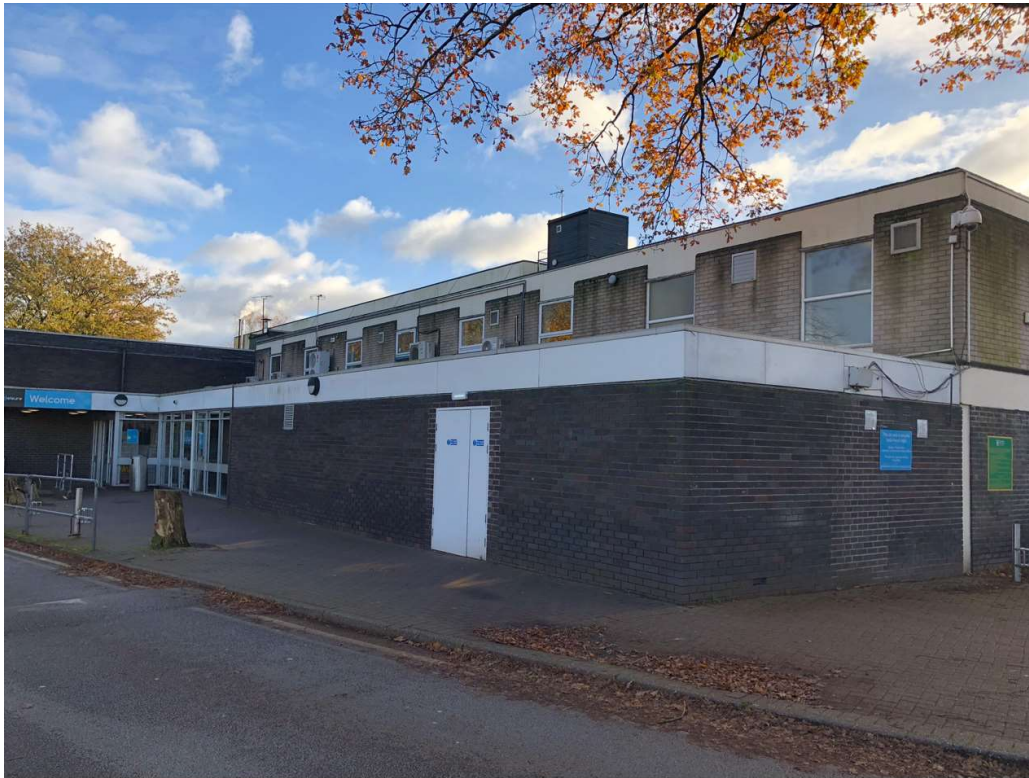
Photo 1: Northeast elevation. Main entrance. Brickwork in reasonable condition.

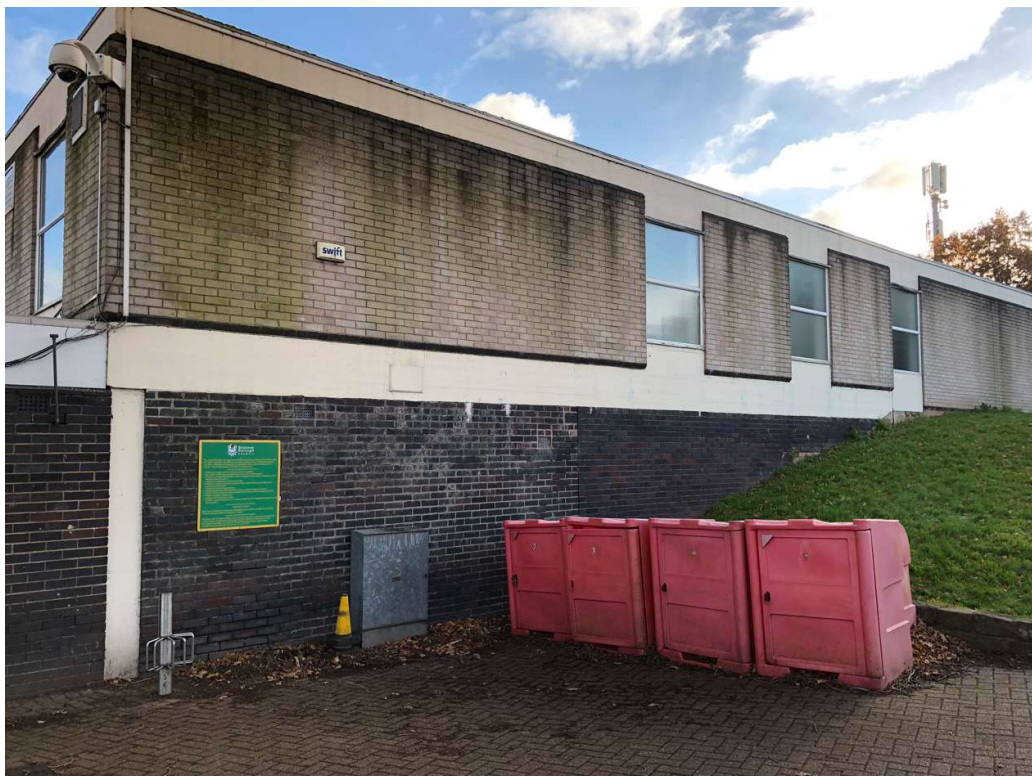
Photo 2: Northwest elevation. Brickwork in reasonable condition.

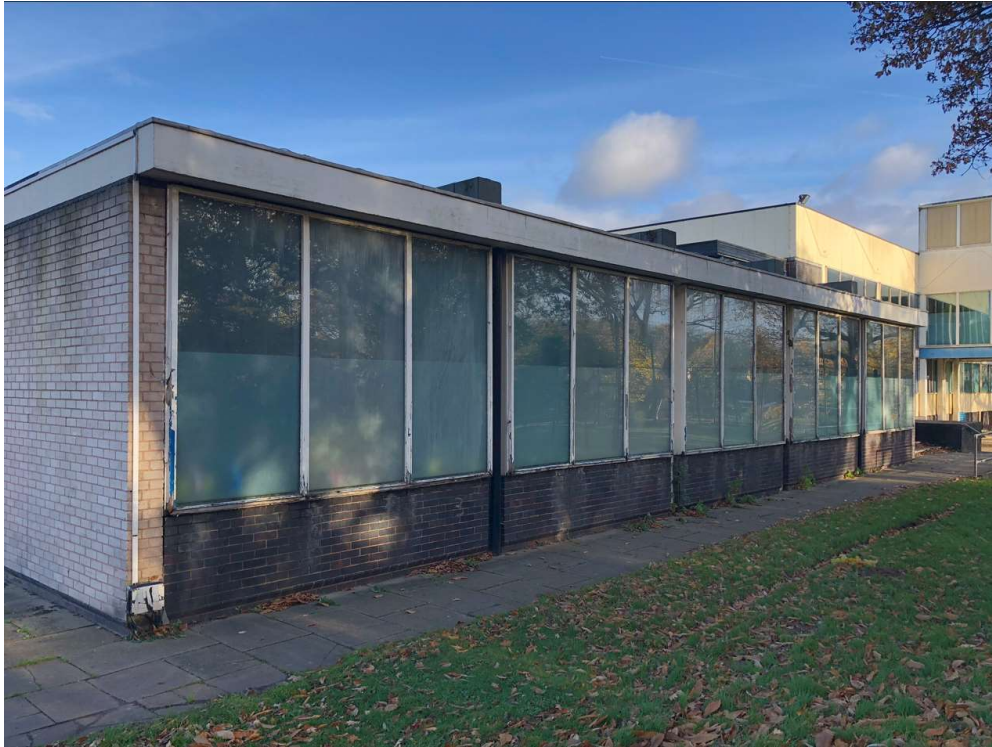
Photo 3: Southwest elevation, Teaching Pool. The timber framed windows are rotten and require replacement.

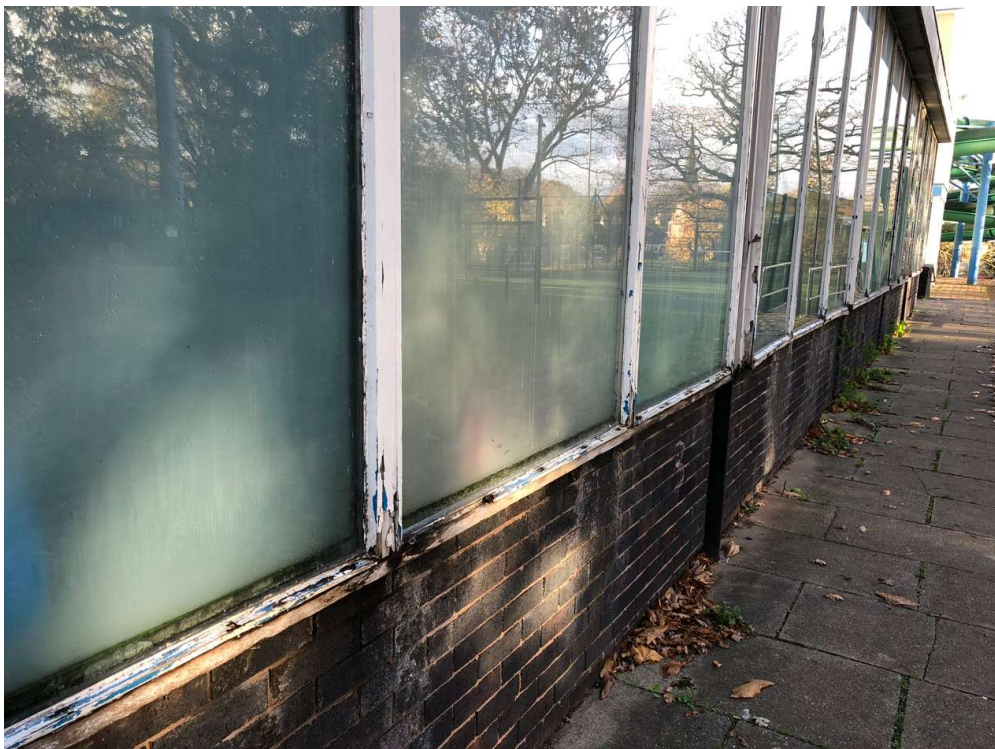
Photo 4: Close-up photo on the rotten frames.

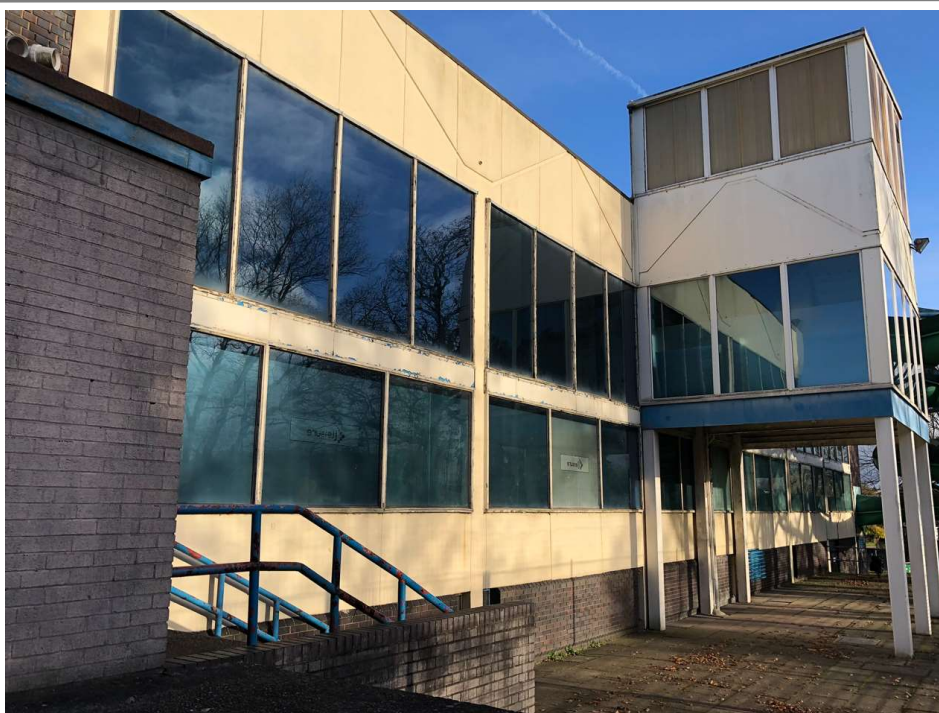
Photo 5: Southwest elevation, Main Pool. The timber framed windows are rotten and require repair or replacement. The two storey frame to the right of the photo is the access to the water slide that is no longer in use.

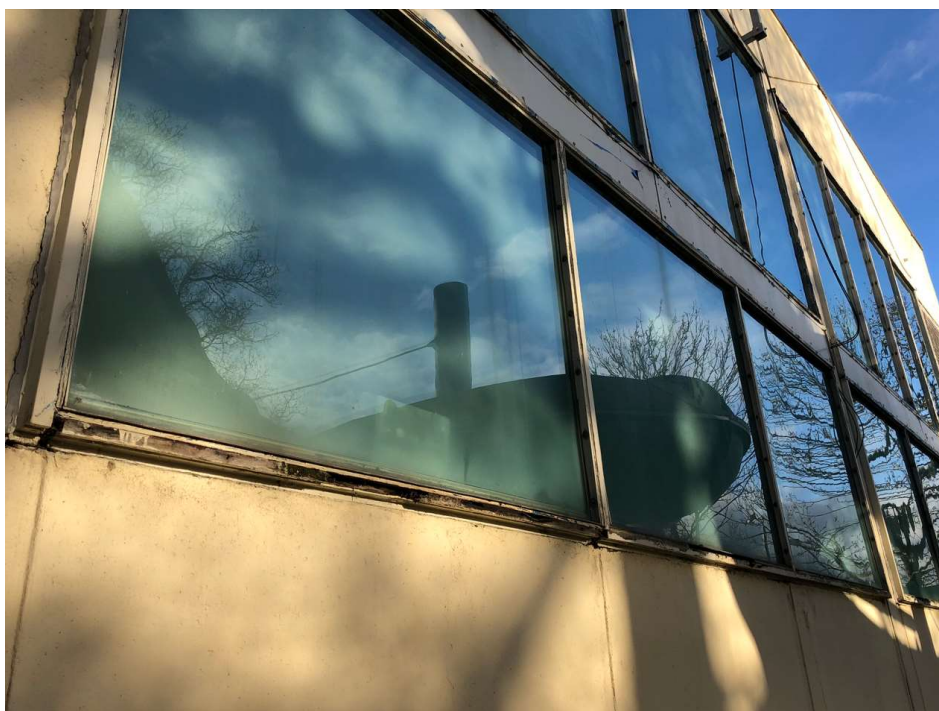
Photo 6: Close-up photo on the rotten frames.

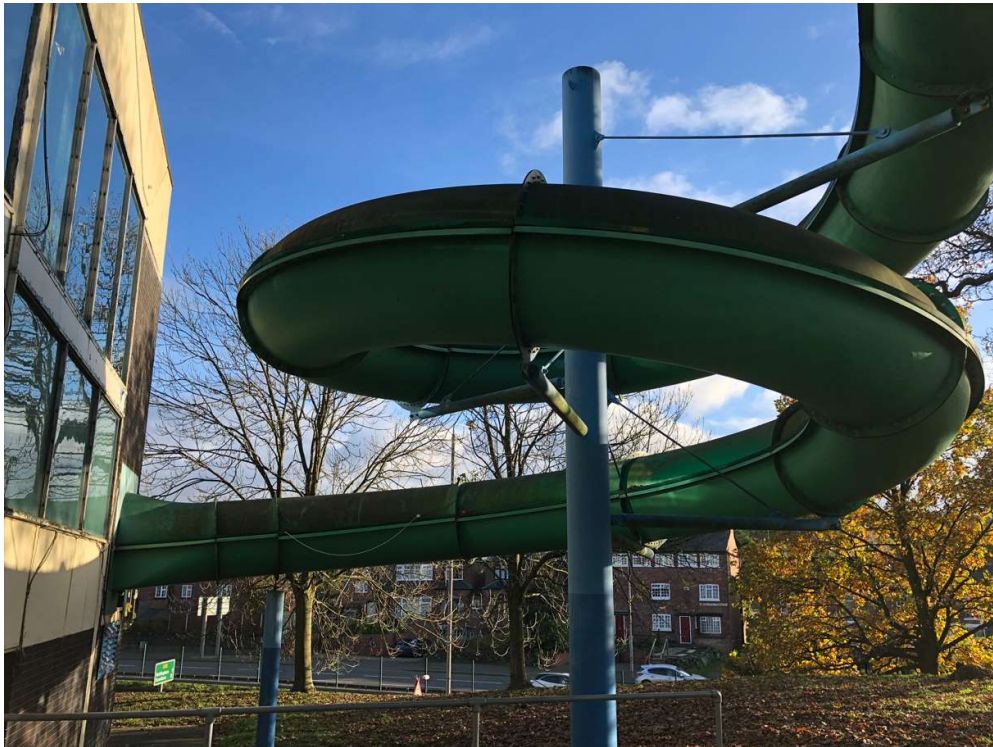
Photo 7: Redundant water slide. Supporting steelwork is in reasonable structural condition.

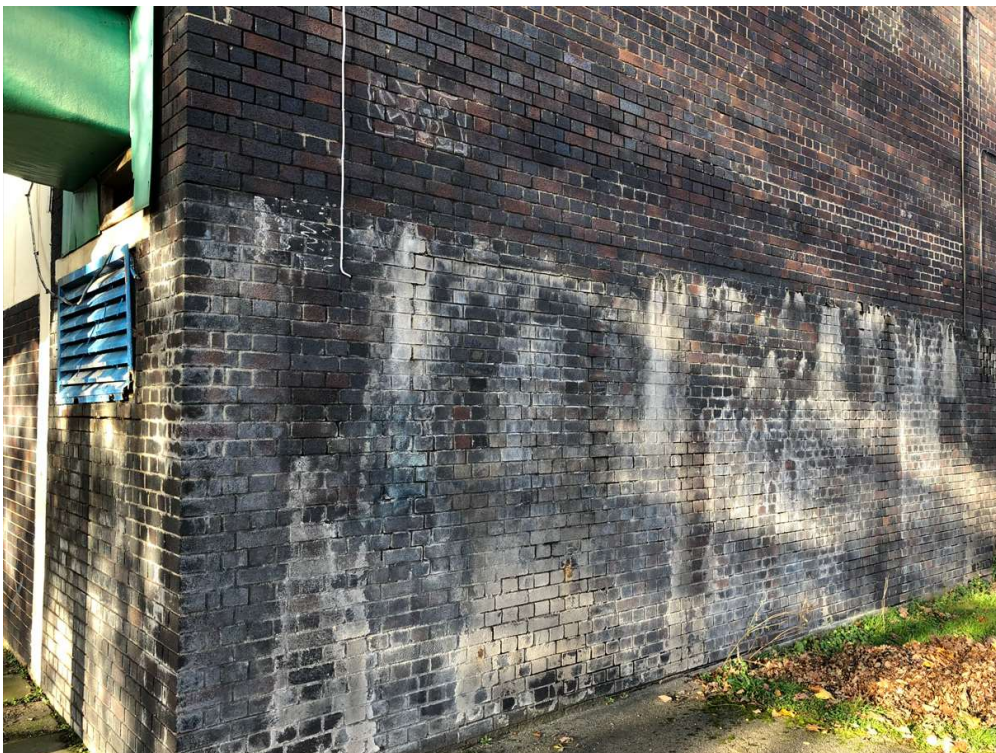
Photo 8: South corner. Stained brickwork, but the cause could not be determined. The swimming pool tank basement area is behind this wall.

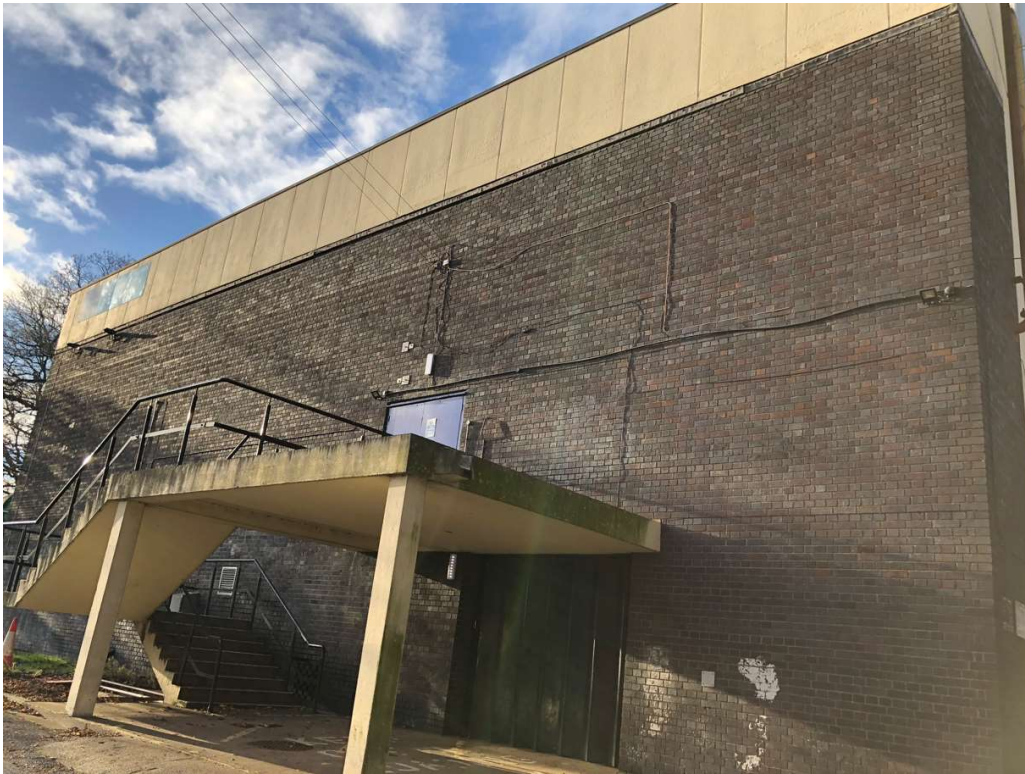
Photo 9: South elevation. Concrete escape stairs from Main Pool.

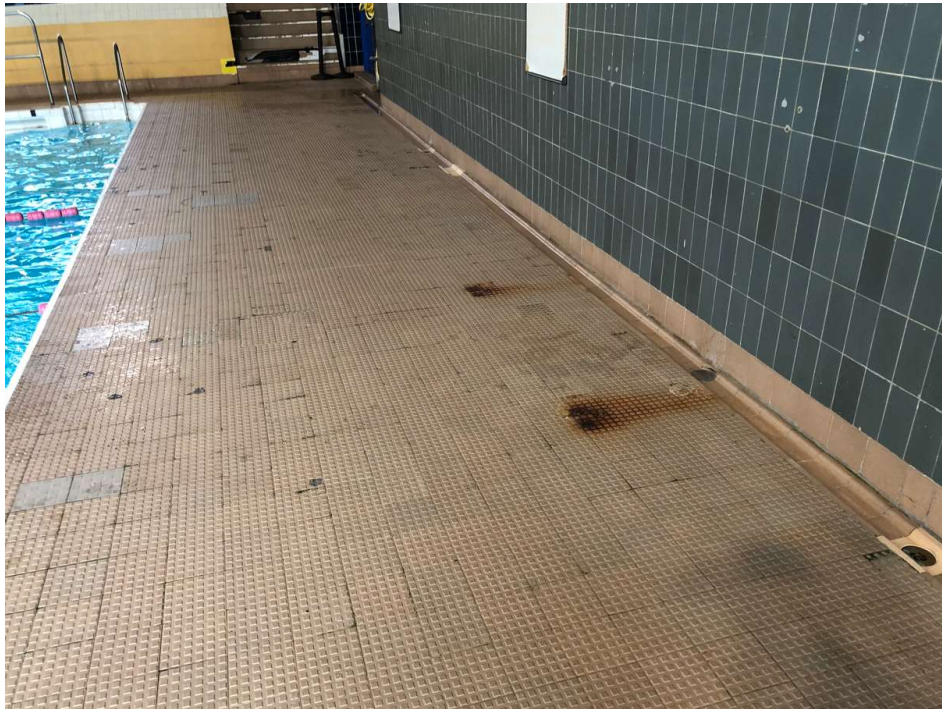
Photo 13: Walkway around the end of the Main Pool. Staining present where corrosion is occurring as the floor is no longer watertight due to equipment having been bolted to the floor. Corrosion mirrored to underside of this floor in the pool basement.

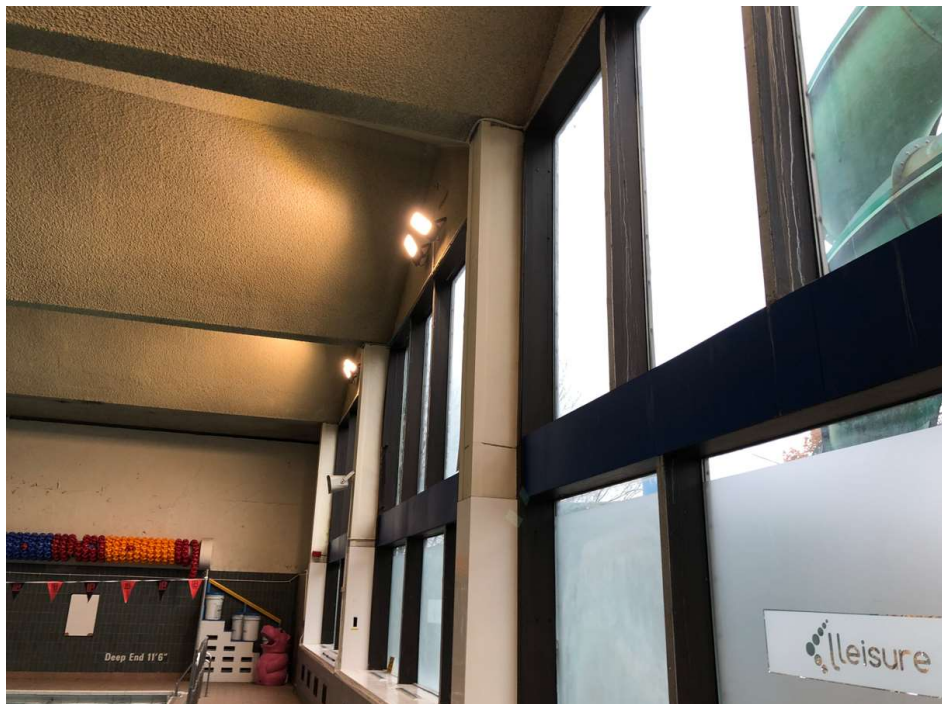
Photo 14: Columns and timber frame curtain walling on southwest elevation. These are the (repaired) columns that have corroded in the pool basement below.

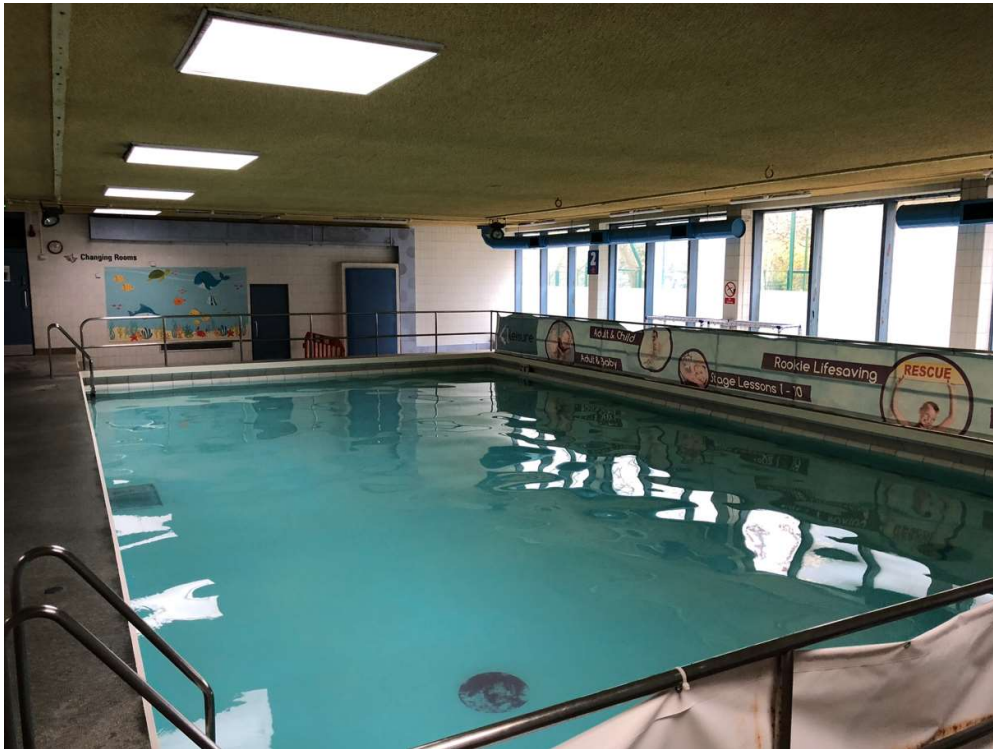
Photo 15: Internal view of Teaching Pool.

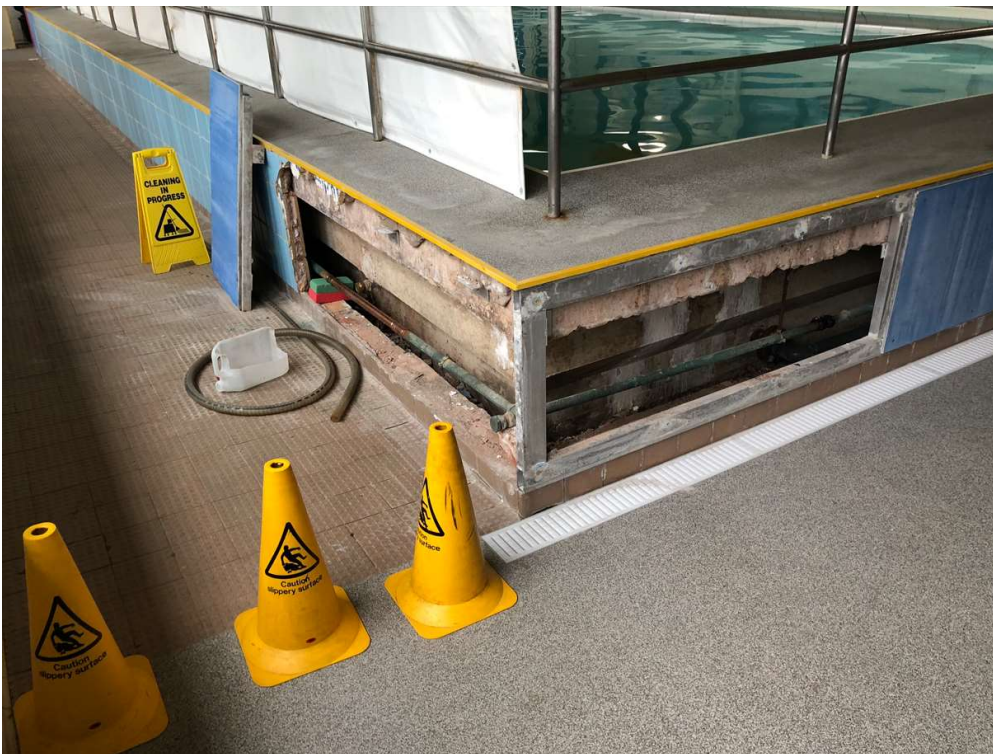
Photo 16: Repairs to the Teaching Pool tiled surround were being completed at the time of our inspection.

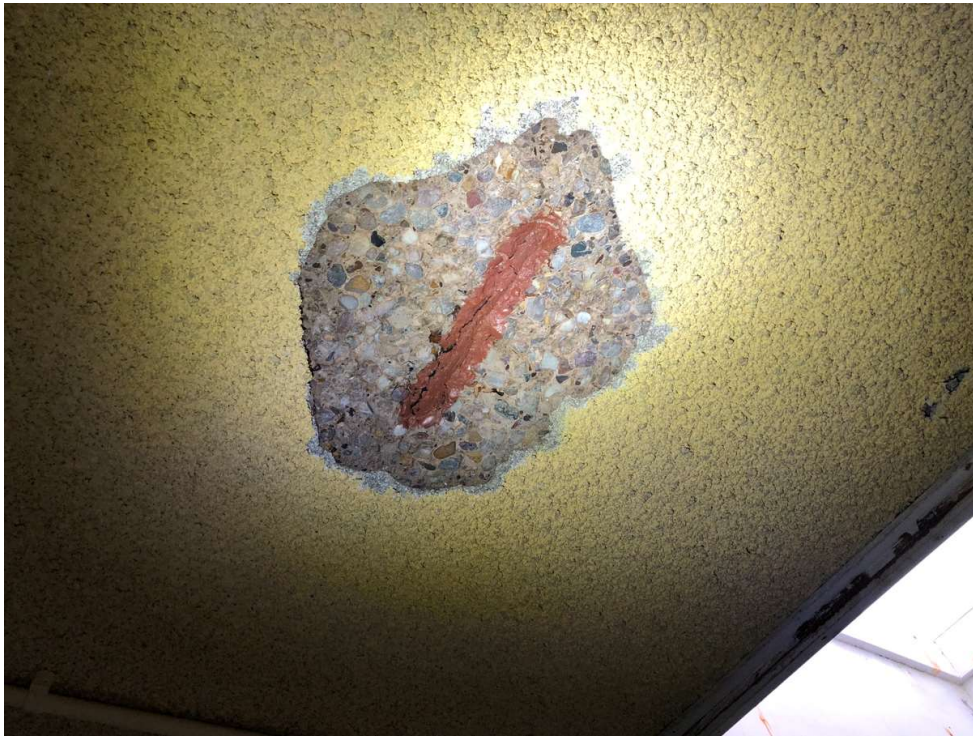
Photo 17: Spalled concrete to the soffit of the Teaching Pool roof. The reinforcement has been coated post-defect to protect it from further corrosion.

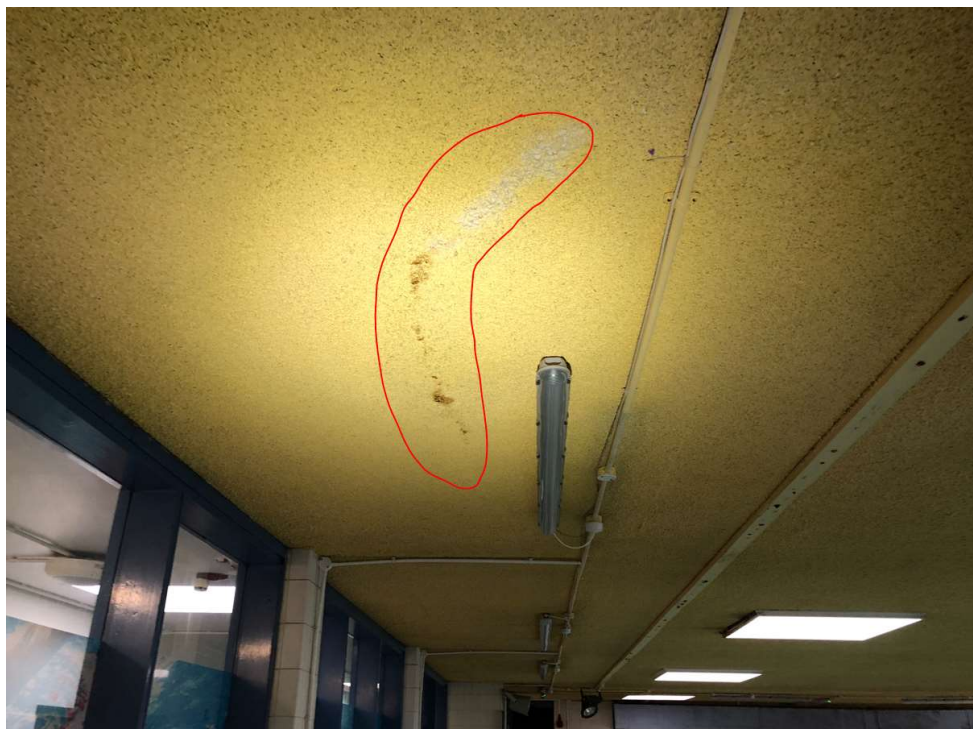
Photo 18: Further signs of reinforcement corrosion to the soffit of the Teaching Pool, staining the sprayed coating (circled in red on the photo).

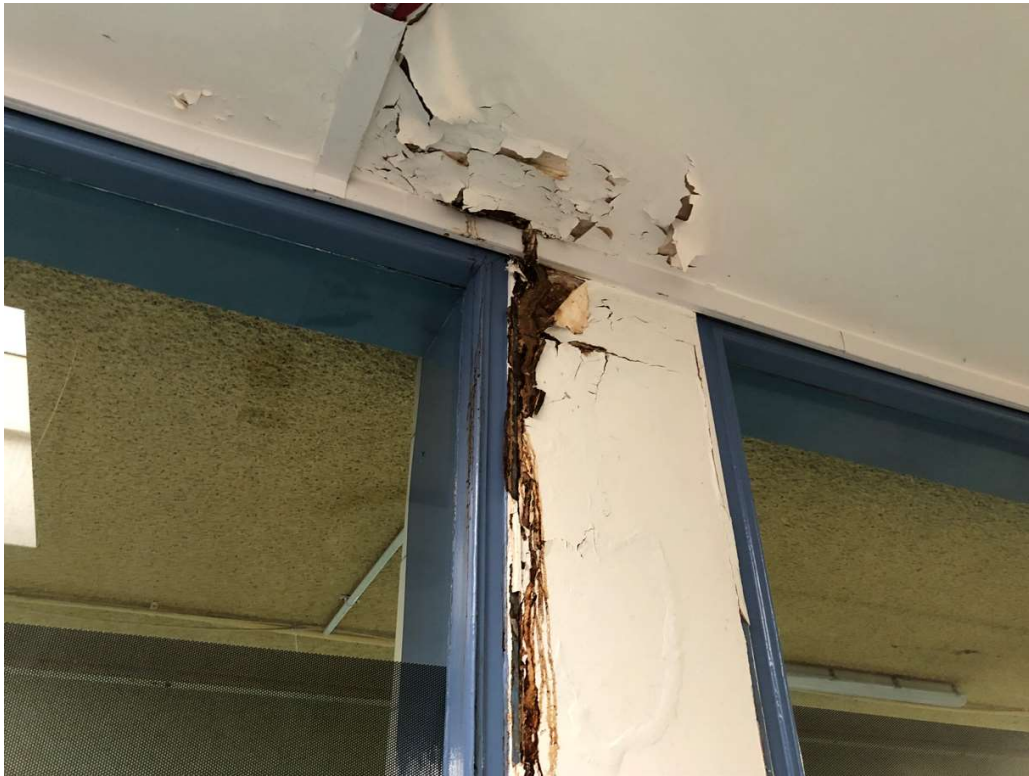
Photo 19: Roof leak causing damage at the top of an internal Teaching Pool column.

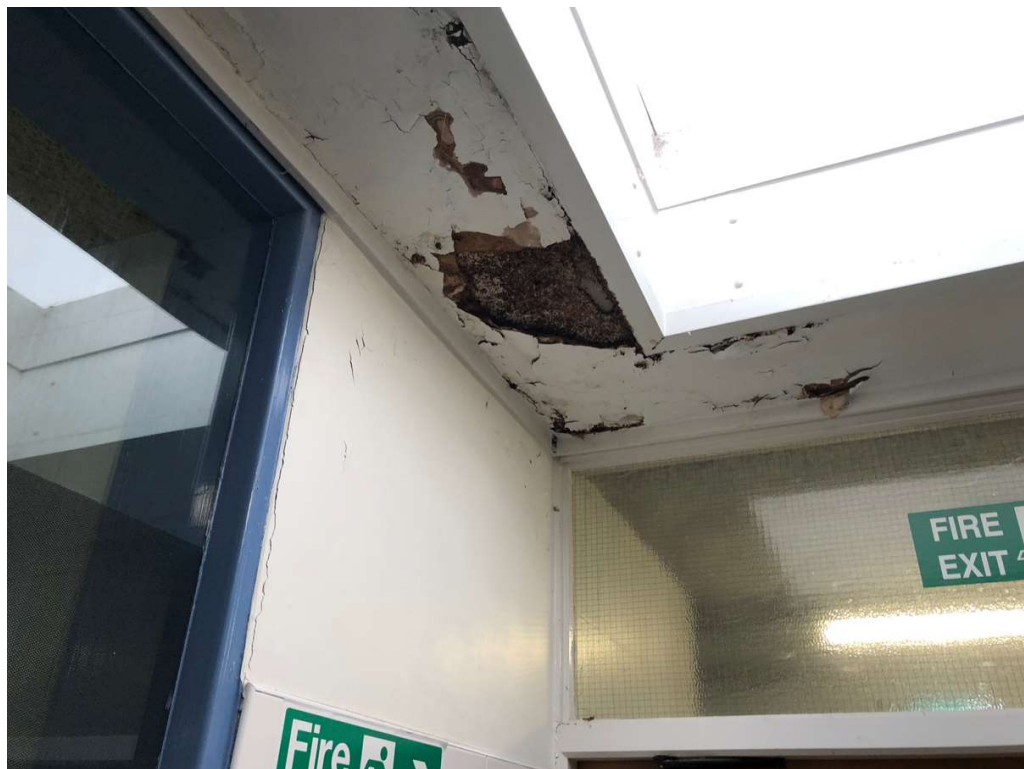
Photo 20: Staining to corridor ceiling due to a leak adjacent to roof light.

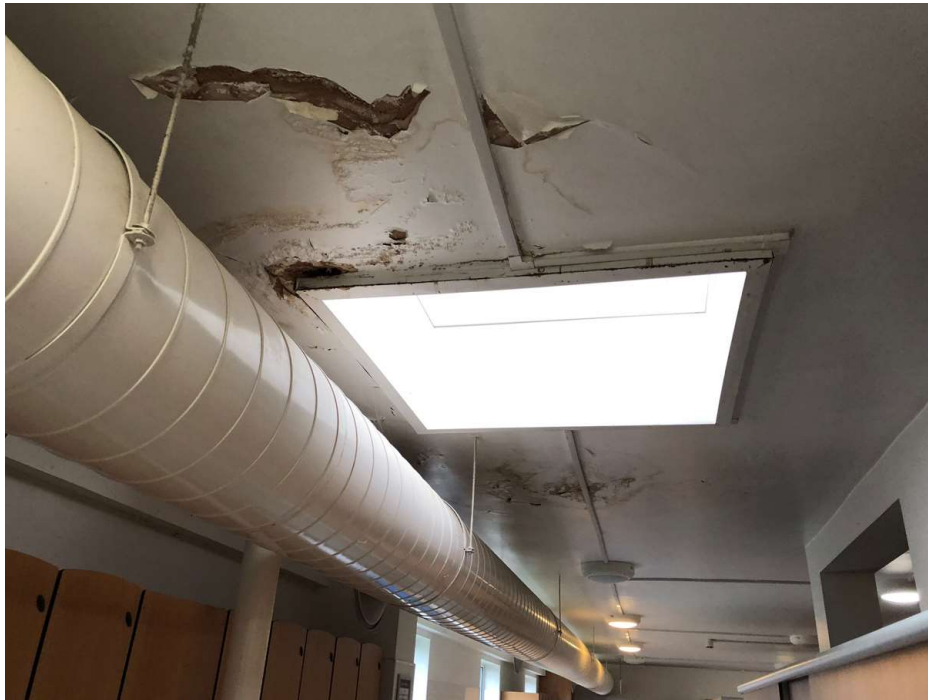
Photo 21: Extensive water damage due to the leaking flat roof over the changing rooms.

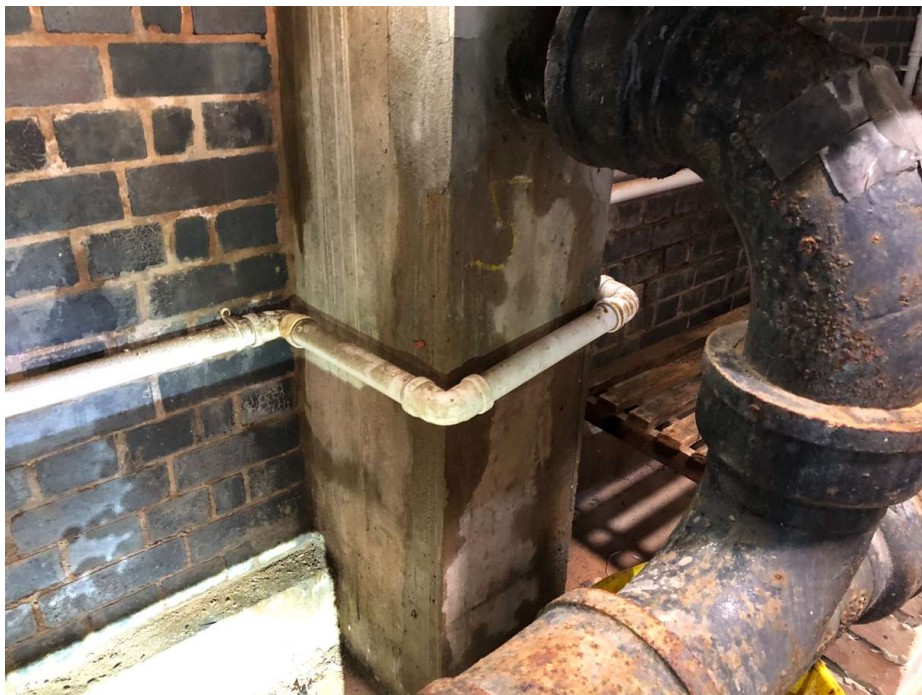
Photo 22: Typical concrete column on the southwest elevation. This column has been previously repaired but is still visibly damp. A drainage pipe, probably a roof RWP, is cast into the column. If this pipe is leaking, which appears to be the case, water will be penetrating deep into the column causing corrosion of the reinforcement.

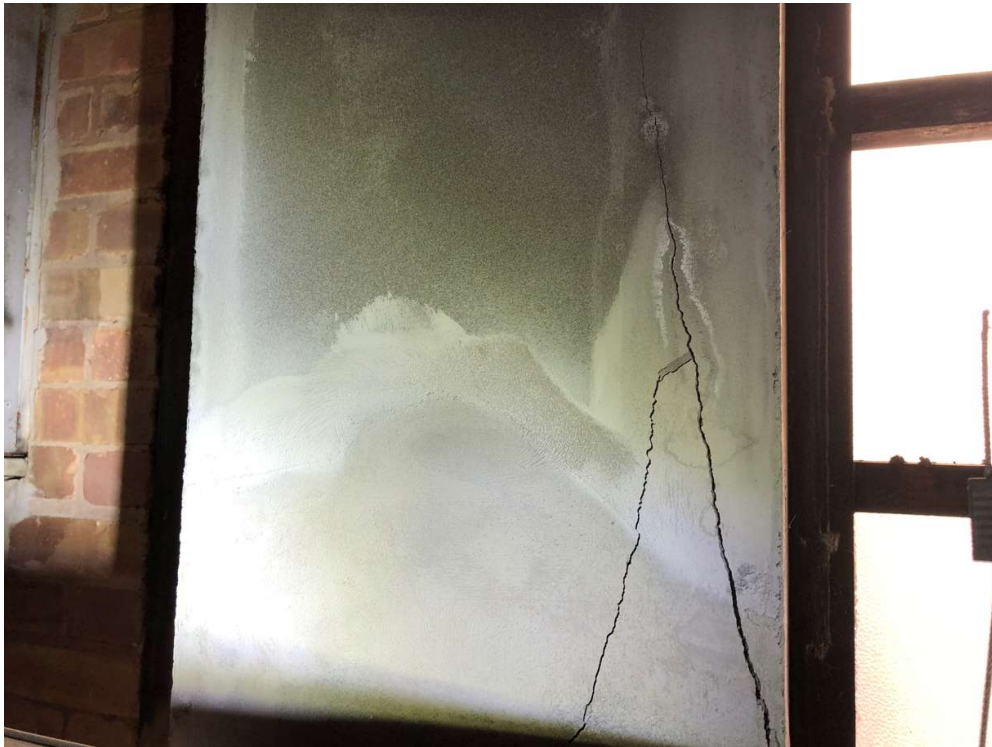
Photo 23: Pool basement column repaired with high strength mortar, but the repair has partially failed.

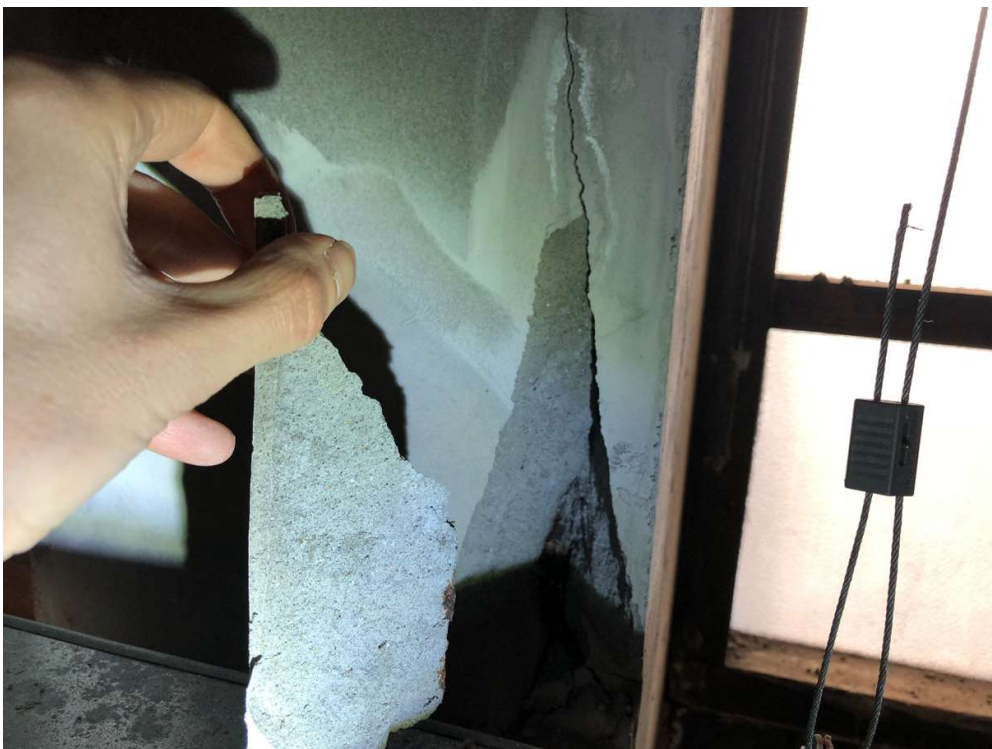
Photo 24: The repair mortar could easily be removed by hand.

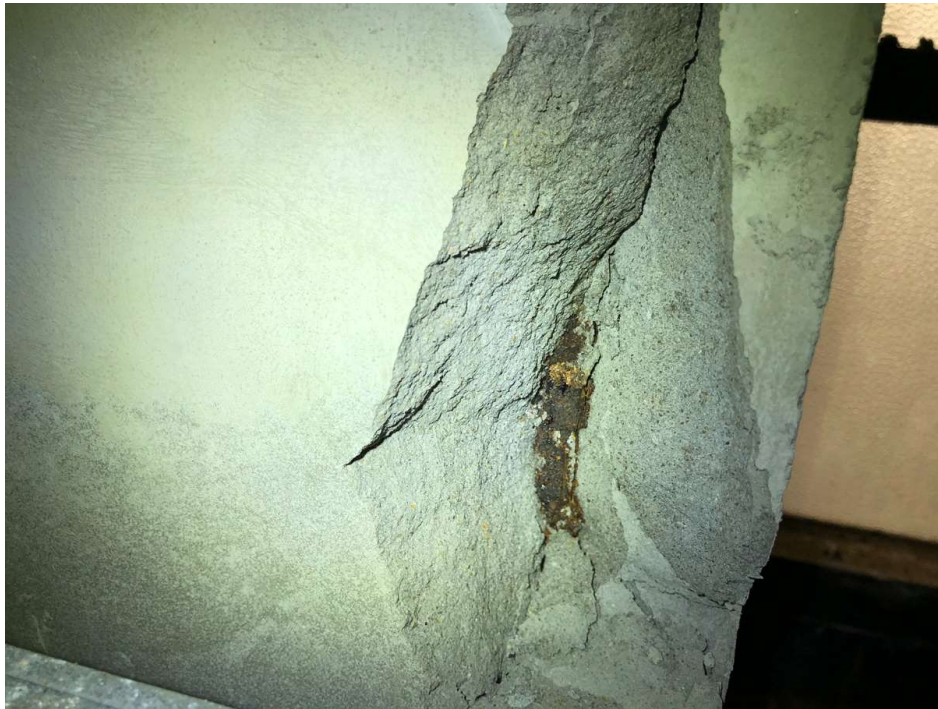
Photo 25: Corroding, expanding, steel reinforcement within the column causing the repair to fail.

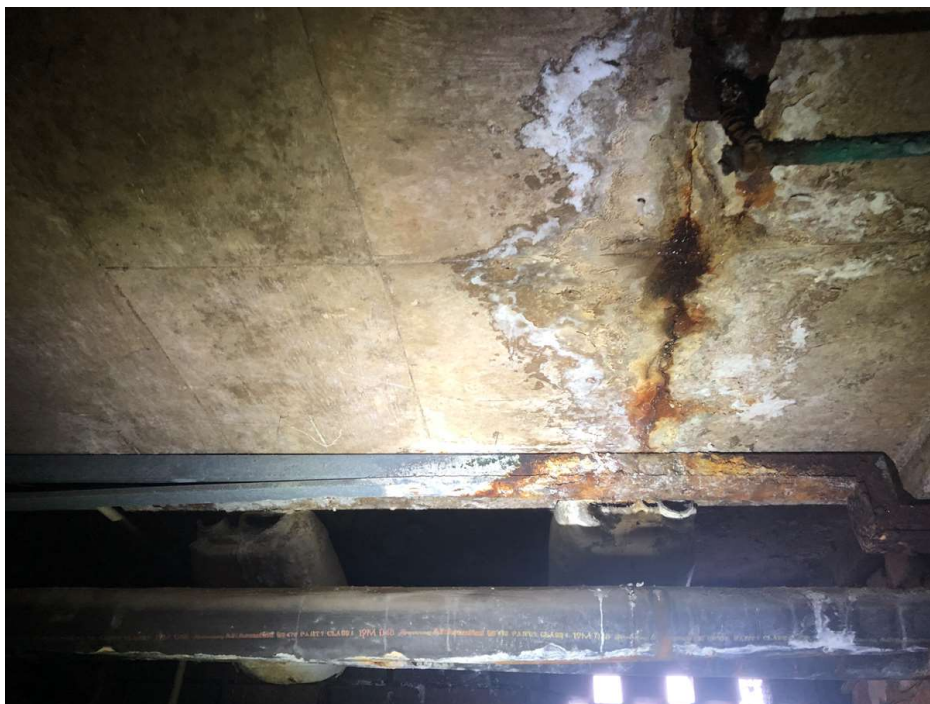
Photo 26: Underside of floor shown in photo 13. Pool water is penetrating the concrete floor causing corrosion of the reinforcement and staining of the soffit.

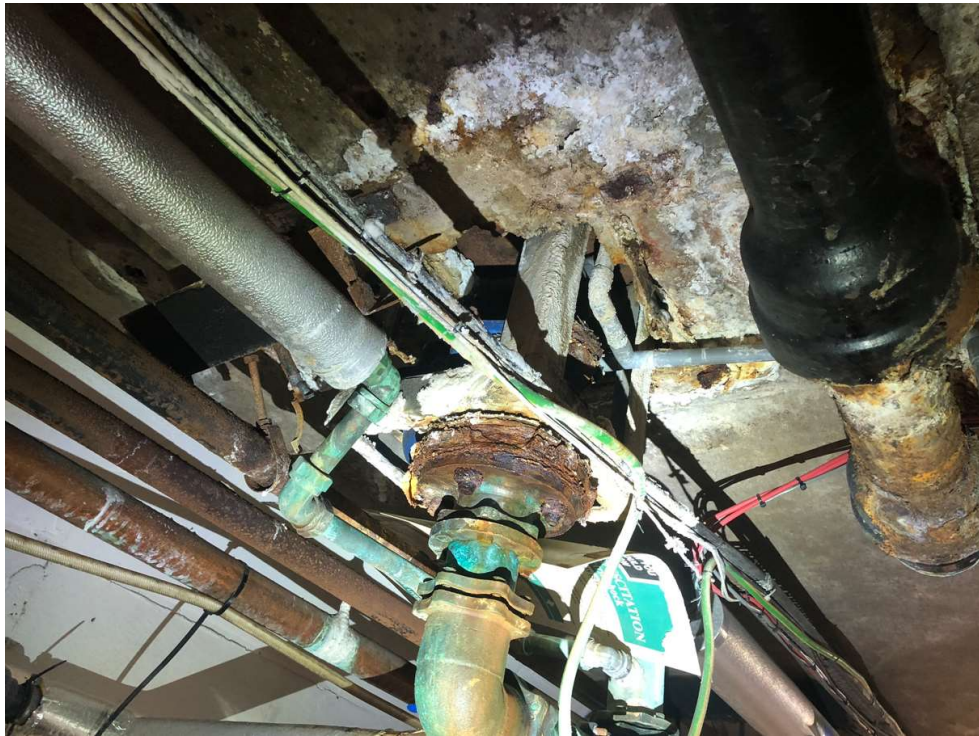
Photo 27: Corroding pipework adjacent to the main swimming pool tank.

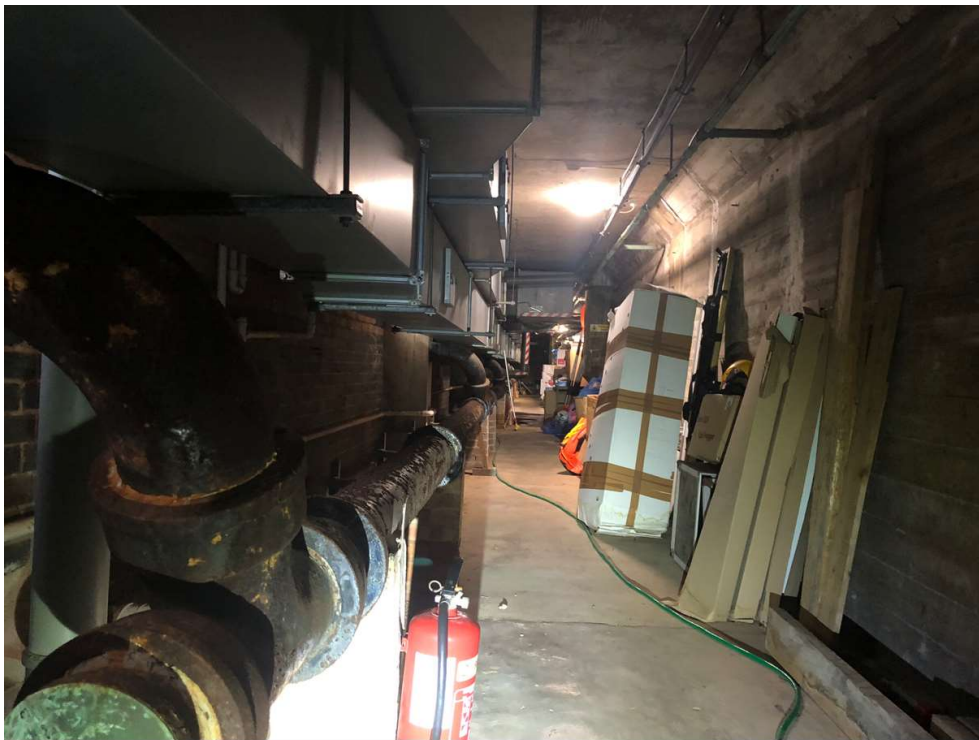
Photo 28: Southwest (repaired) columns on the left with a drainage pipe cast into each one. Reinforced concrete swimming pool tank is on the right of the photo.

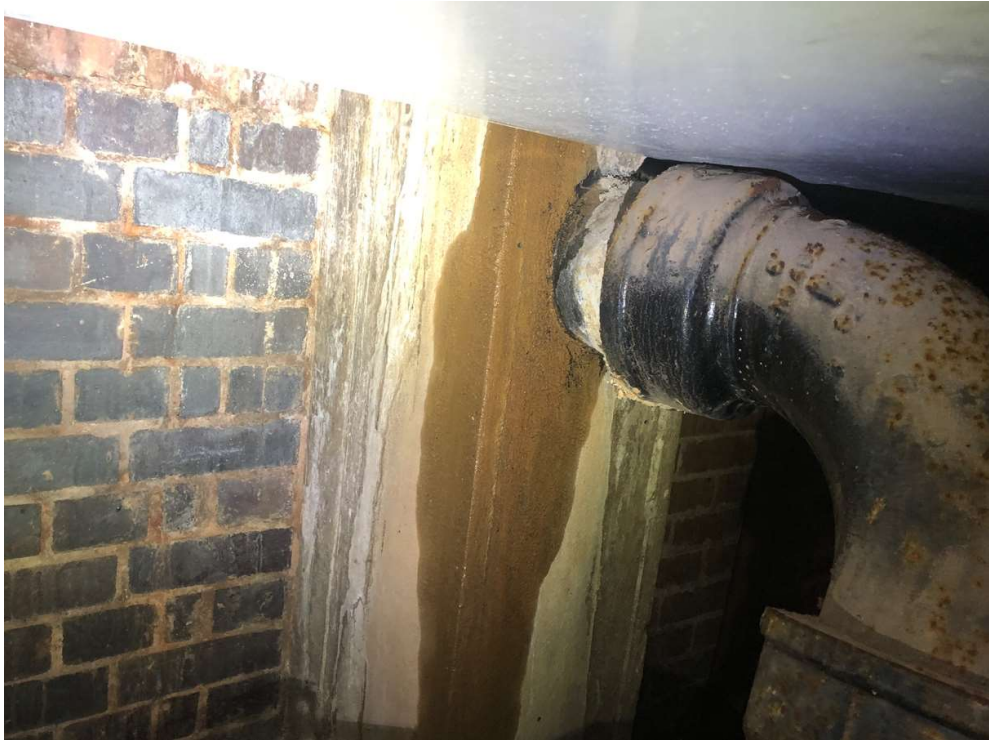
Photo 29: Another example of saturated concrete column on the southwest elevation of the Main Pool building.

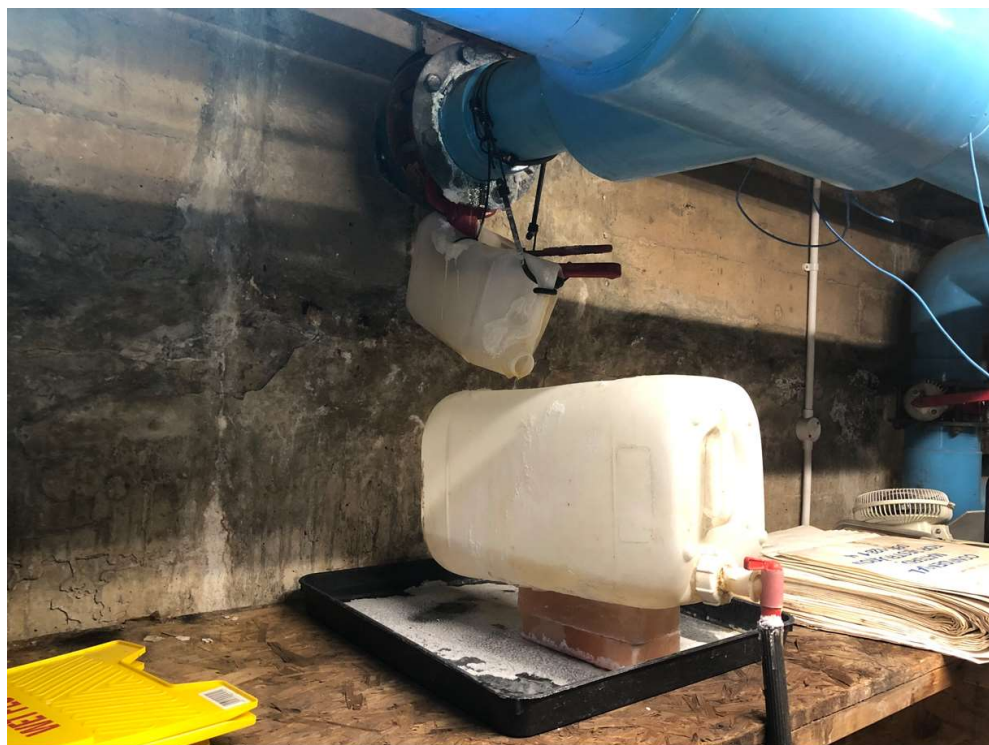
Photo 30: An interesting way of catching the leaks.

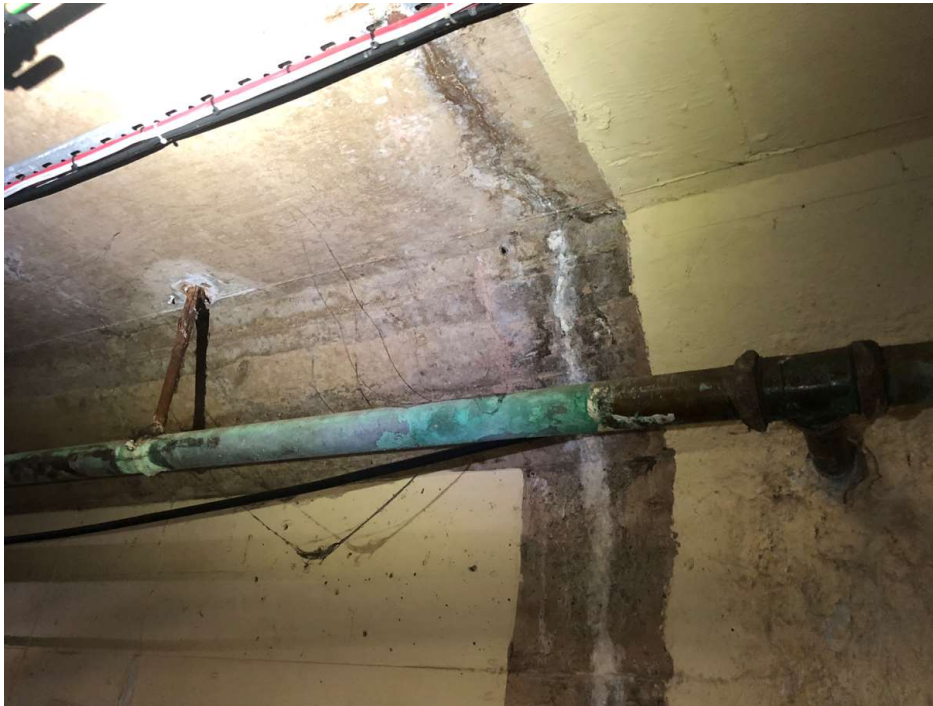
Photo 31: Main Swimming Pool tank. Vertical cracks are present in the walls. These are not considered structurally significant but should be surveyed annually to check their severity does not change.

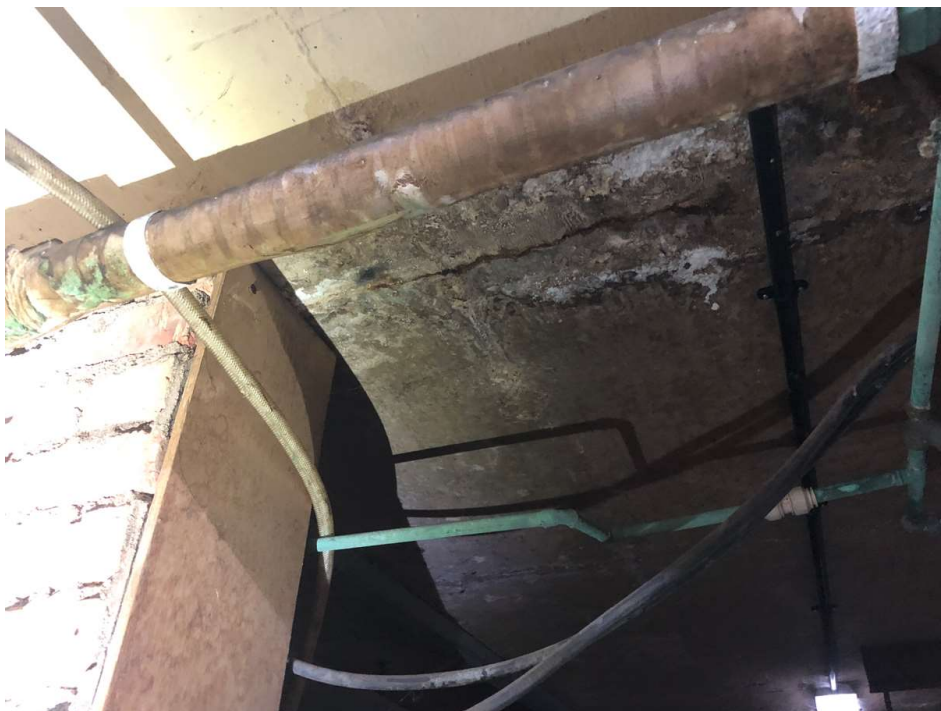
Photo 32: Example of corrosion to underside of floor slab around the swimming pool.

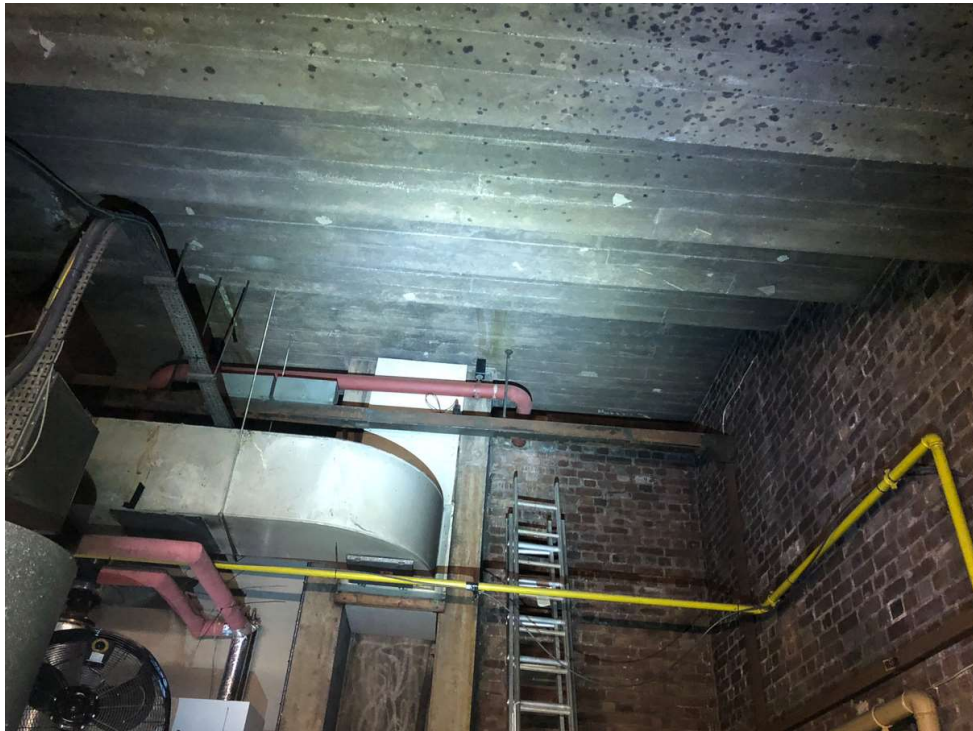
Photo 33: Underside of spectator seating formed in reinforced concrete.

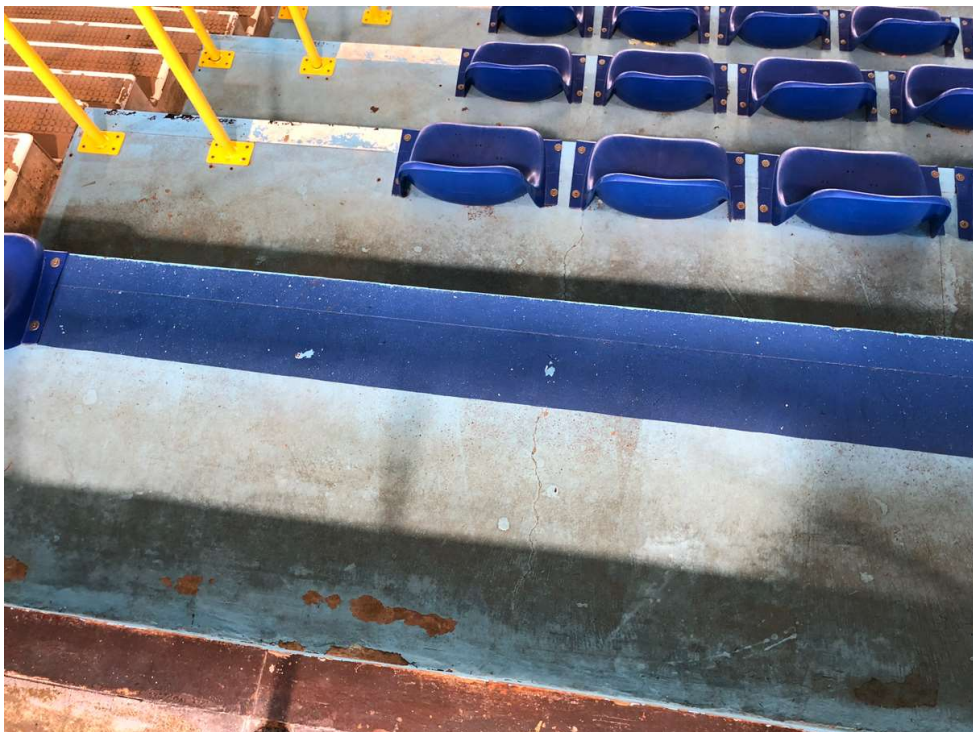
Photo 34: Hairline cracks are visible in the top and to the underside of the concrete tiered seating at mid-span. This is typical to every bay between supporting columns but is not considered structurally significant.
