STRUCTURAL APPRAISAL

Bramcote Leisure Centre

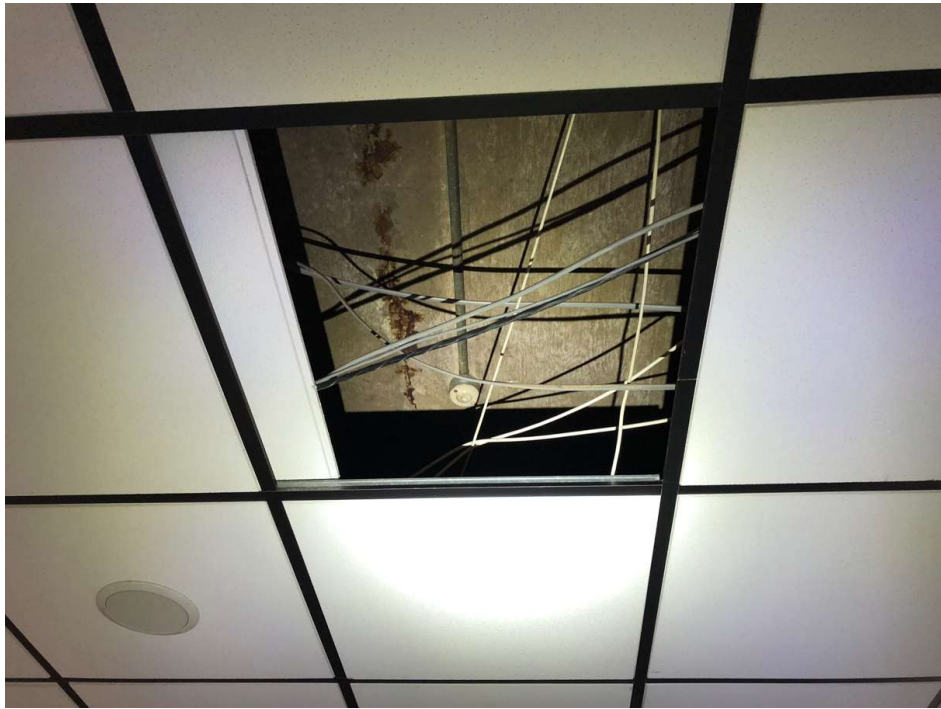
Photo 35: Underside of concrete roof slab, first floor corridor outside the changing rooms. Staining indicates corroding reinforcement due to leaking flat roof finishes above.

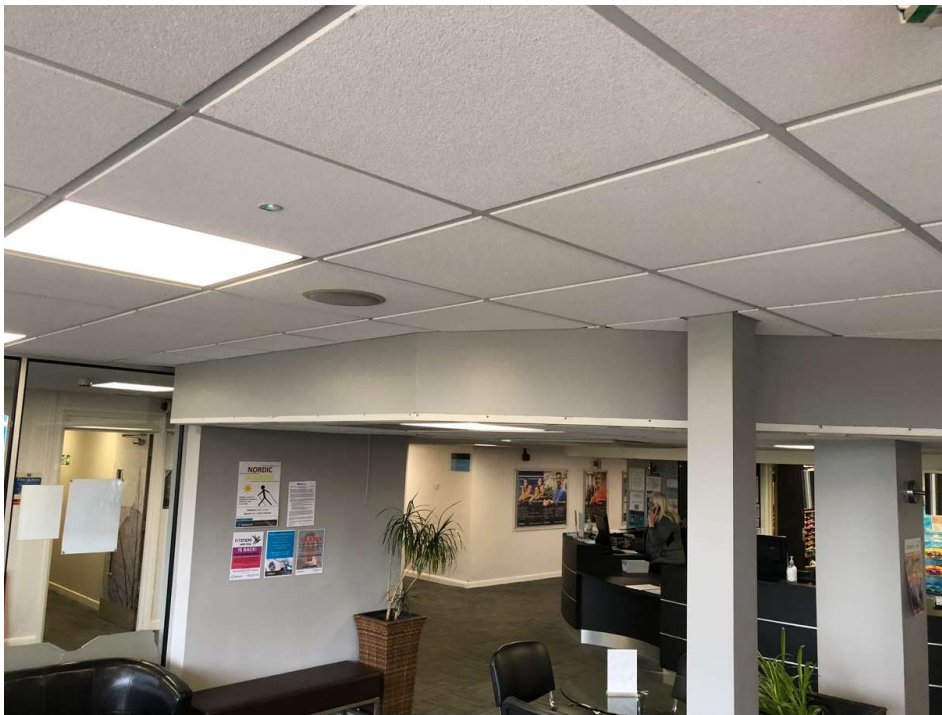
Photo 36: Main reception. The lower area is part of the original building and is a concrete frame. In the foreground, where the ceiling is higher, it is a steel frame extension with a timber joisted flat roof.

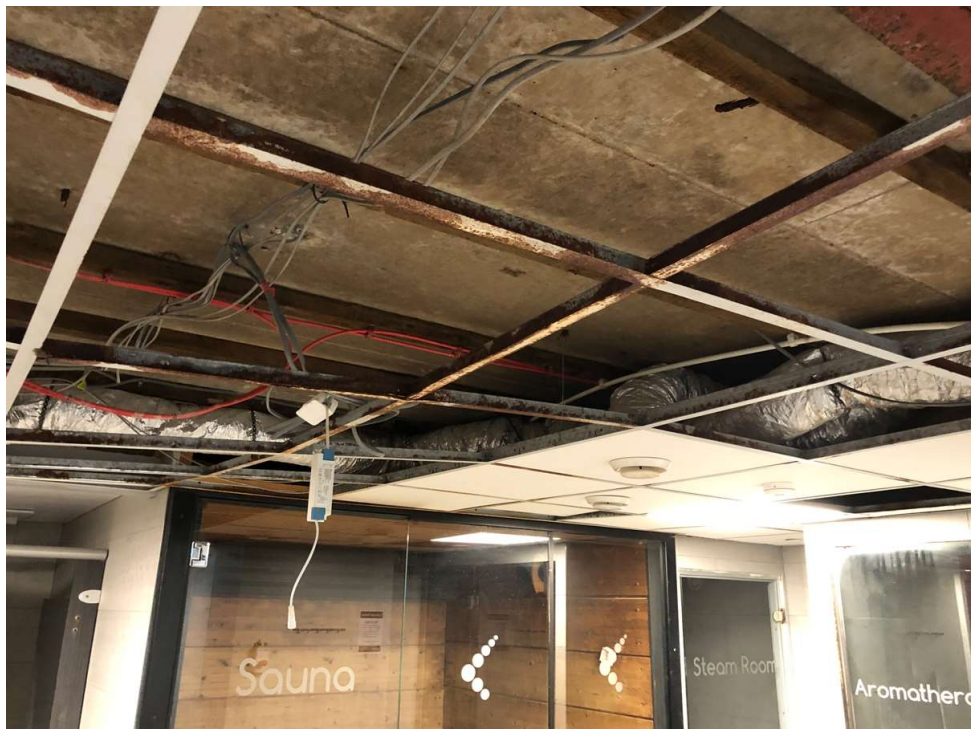
Photo 38: Assumed roof leak in the Spa has caused the suspended ceiling to fail. The roof to the Spa is a concrete flat slab with some supporting steel beams.

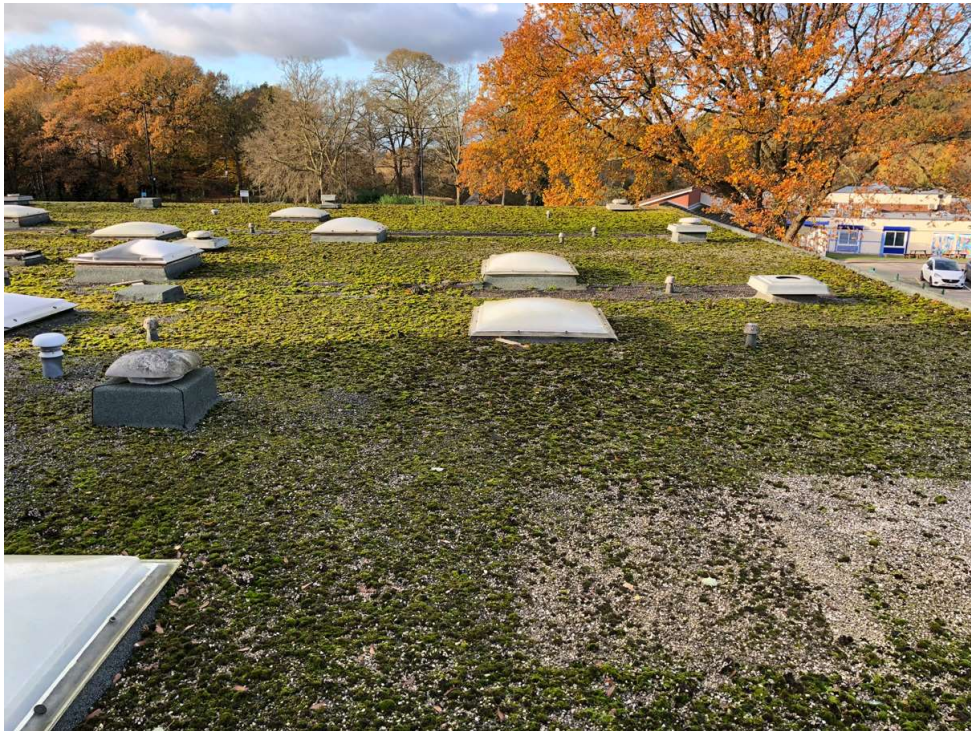
Photo 39: Flat roof over main entrance and Spa area. Heavily vegetated. The felt is in poor condition.

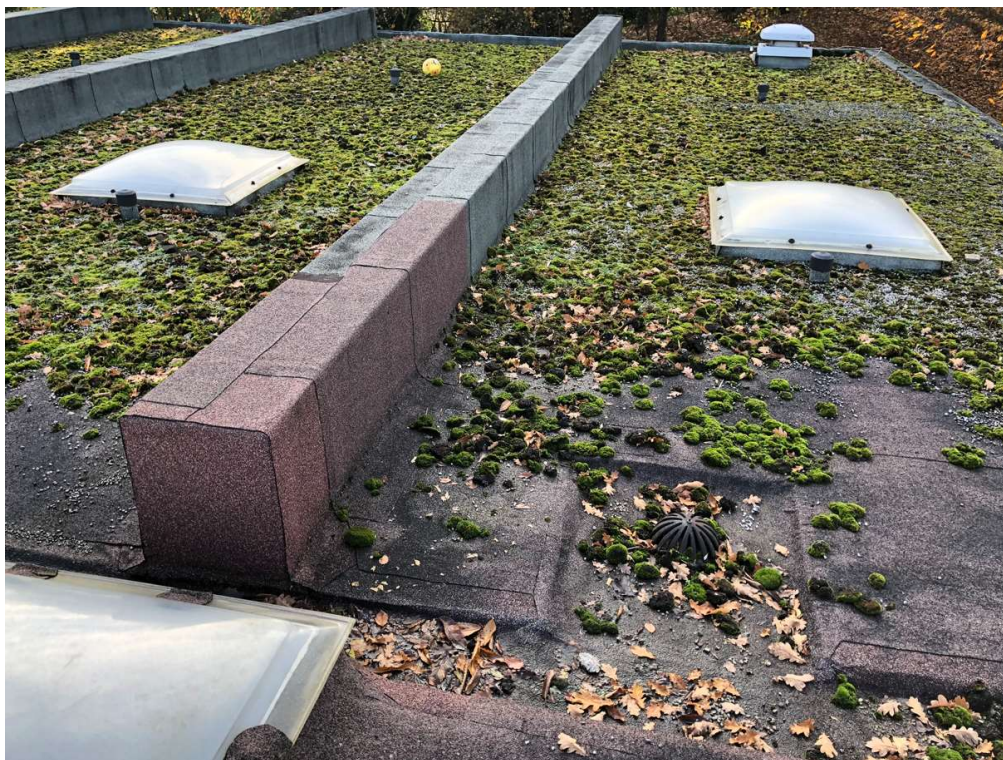
Photo 40: Roof over Teaching Pool. Beams project above.

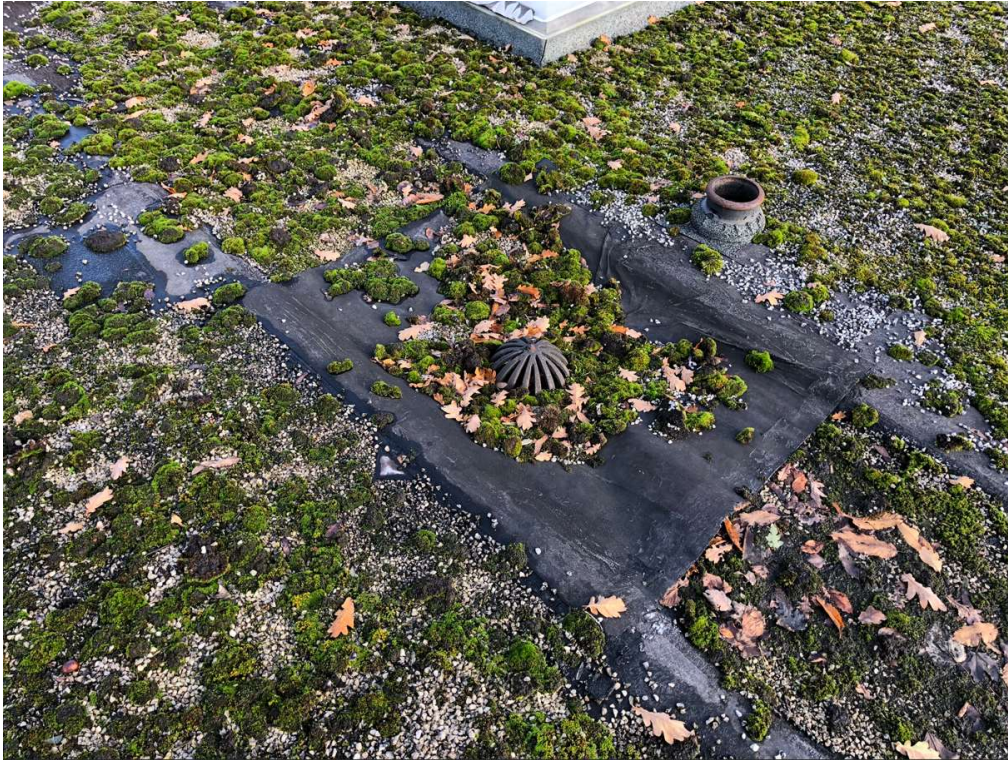
Photo 41: Failing roof felt and drainage.

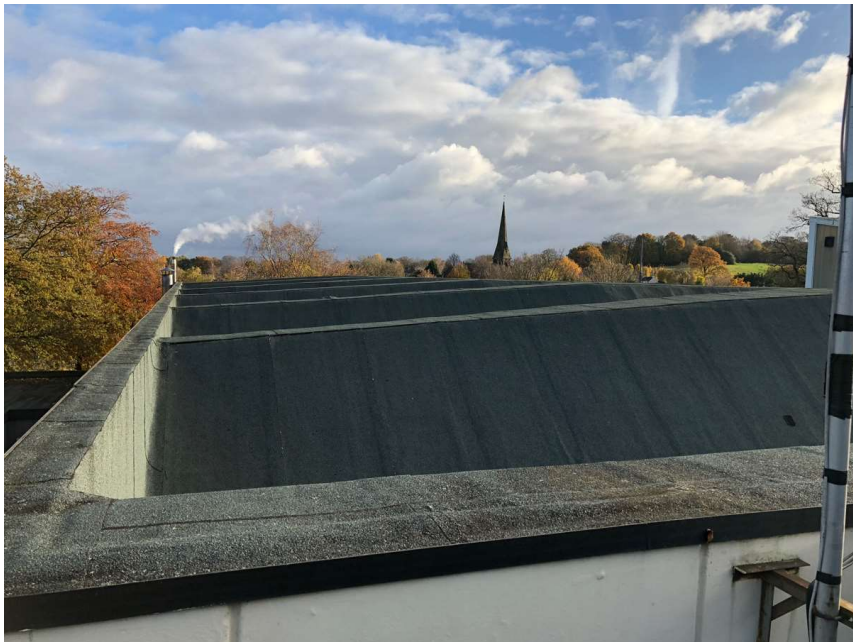
Photo 42: Roof over Main Pool. Structure projecting above. Felt looks in reasonable condition to this part of the building.

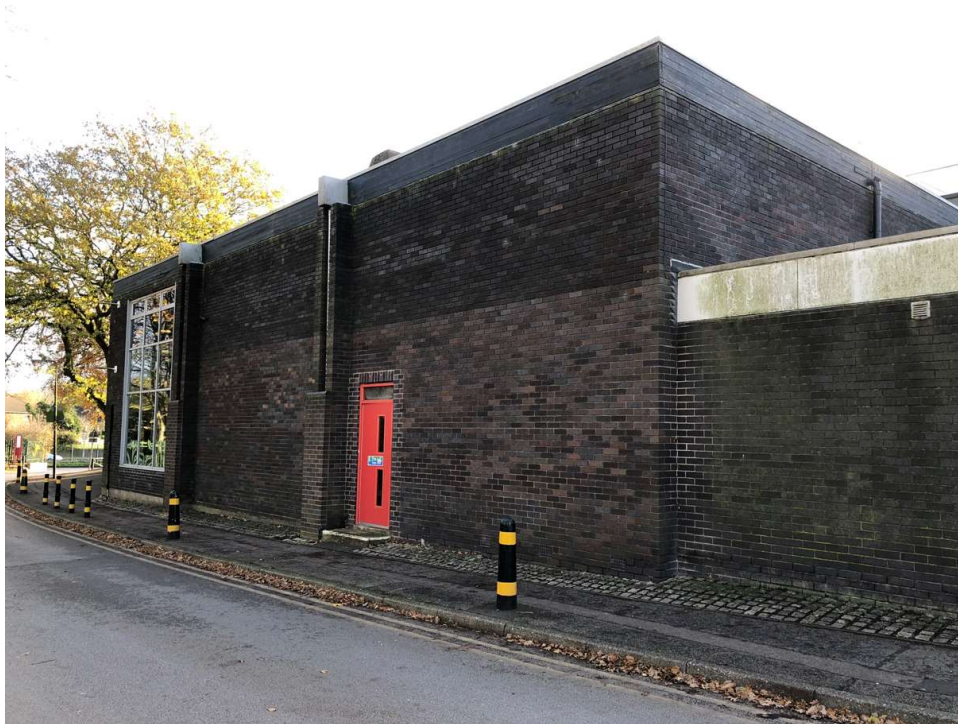
Photo 41: Northeast elevation of fitness suite. Brickwork cavity wall is in reasonable condition.

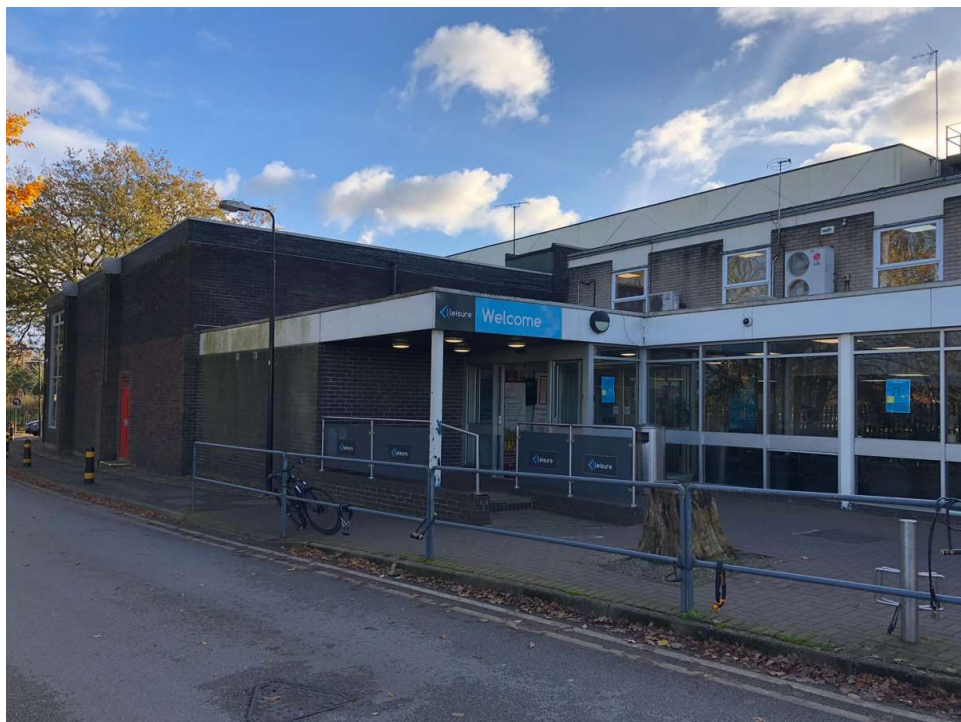
Photo 42: Main entrance, fitness suite 1970s building in background.

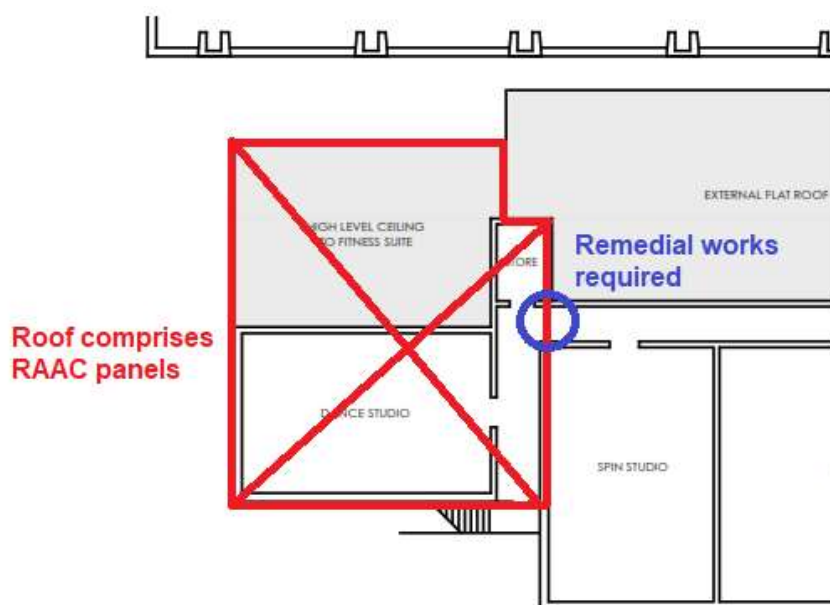
Figure 4: Area requiring urgent remedial works.

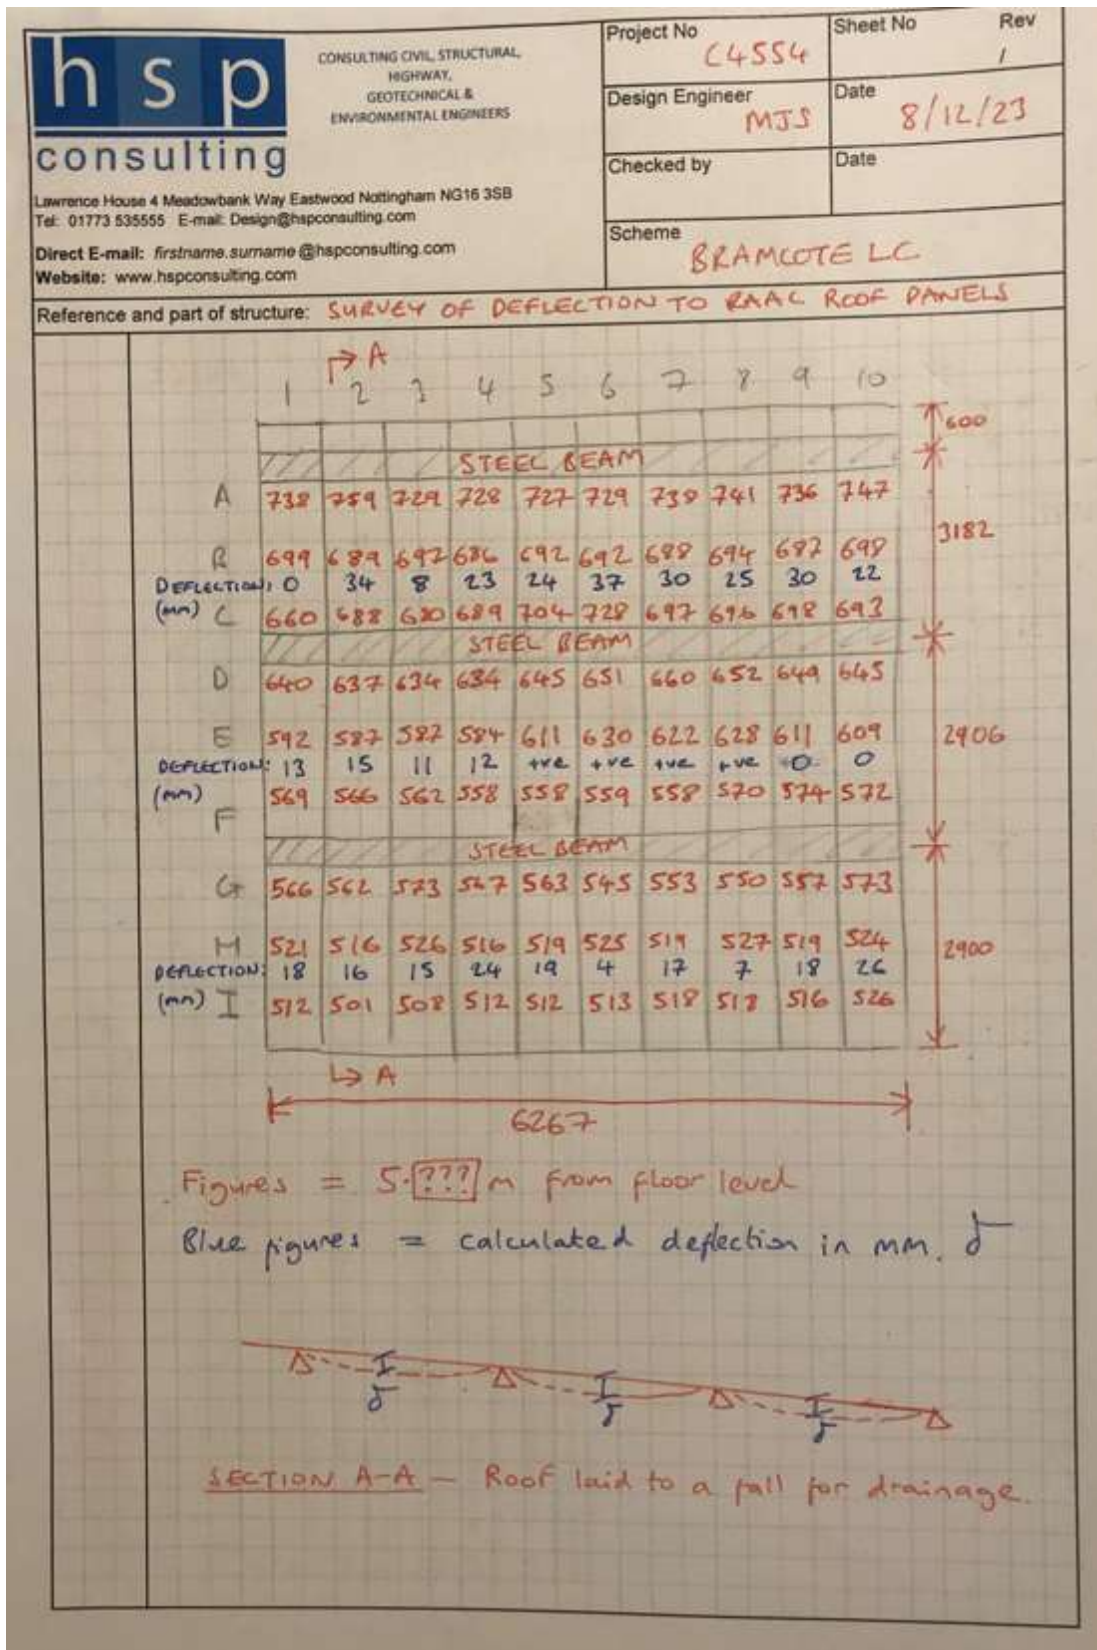
Figure 5: Survey of deflection to RAAC roof panels.

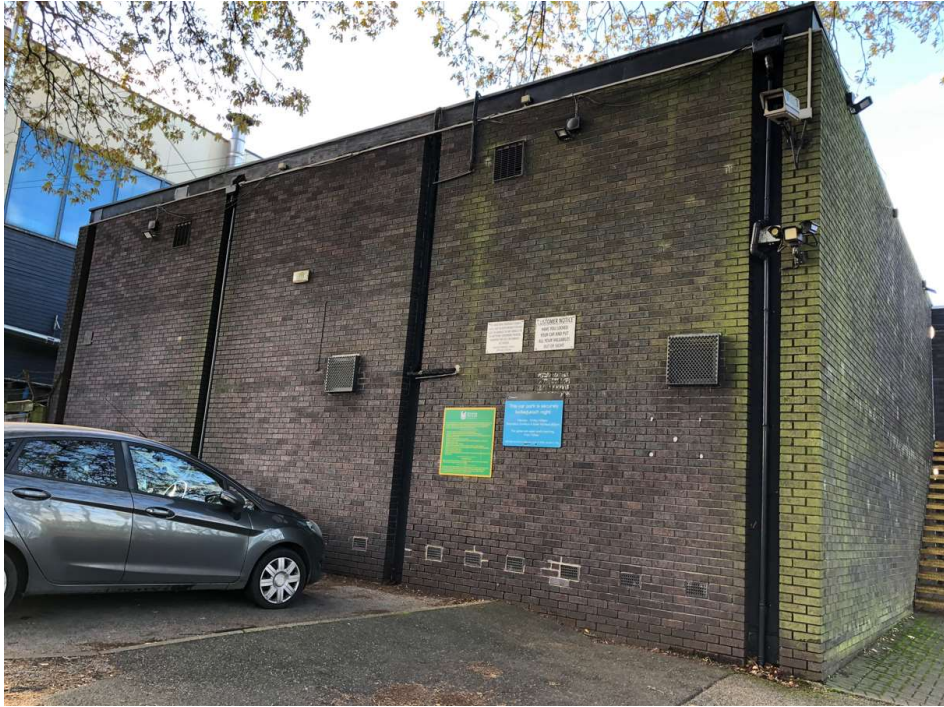
Photo 48: South (end) elevation of RAAC building. Brickwork is in good condition. The roof drains to this end and the RWPs are in recesses within the brickwork. Behind the RWPs are RAAC wall panels painted black. The roof has a small parapet.

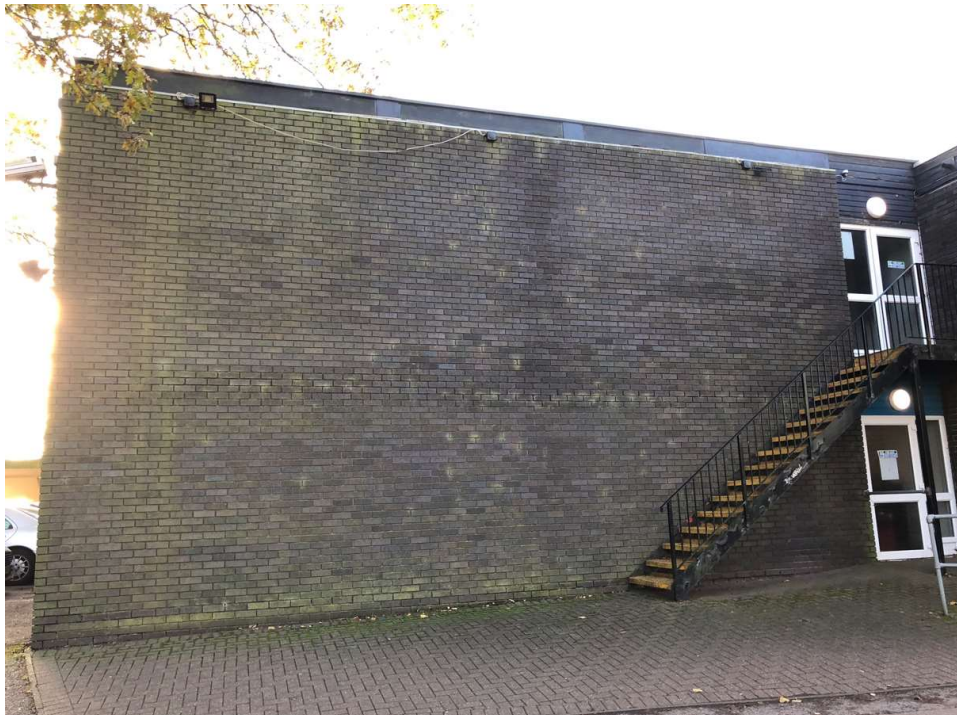
Photo 49: Side elevation of RAAC building. Brickwork is in good condition.

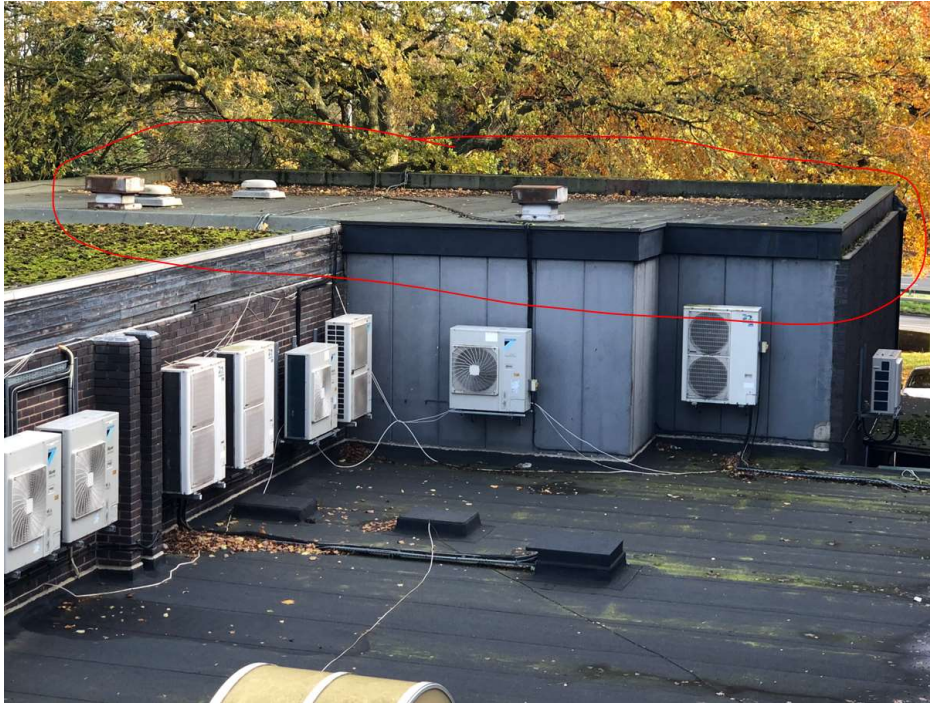
Photo 50: Roof of RAAC building. Laid to a fall towards the far end. The felt appears to be in reasonable condition. The grey vertical wall panels are RAAC.

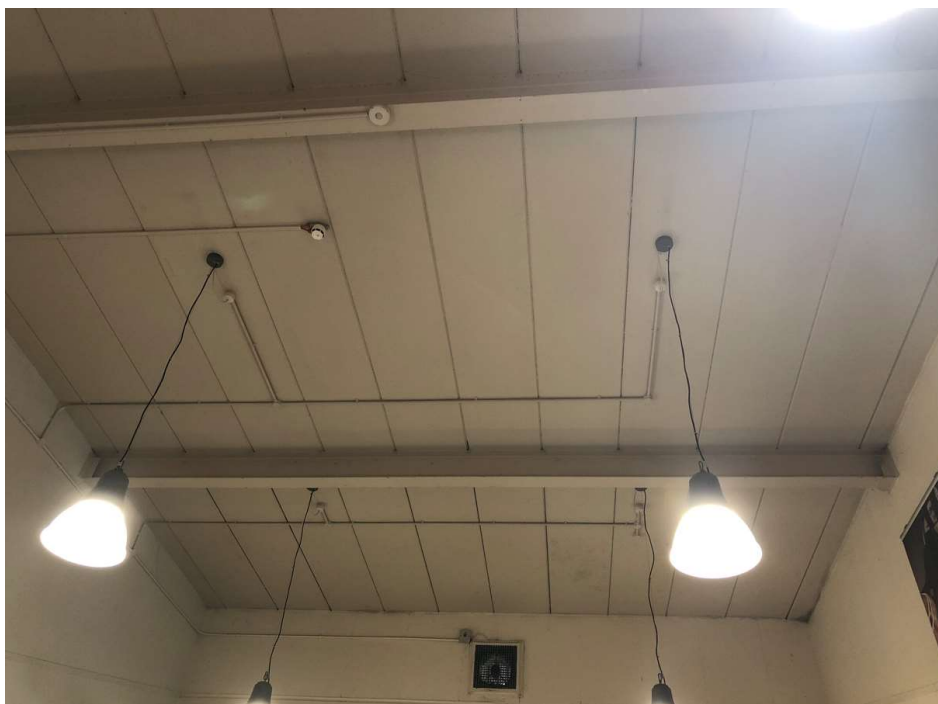
Photo 51: View on RAAC roof panels above fitness suite. The panels span up to 3.1m onto intermediate 254mm steel Universal Beams and onto the RAAC walls at the ends.

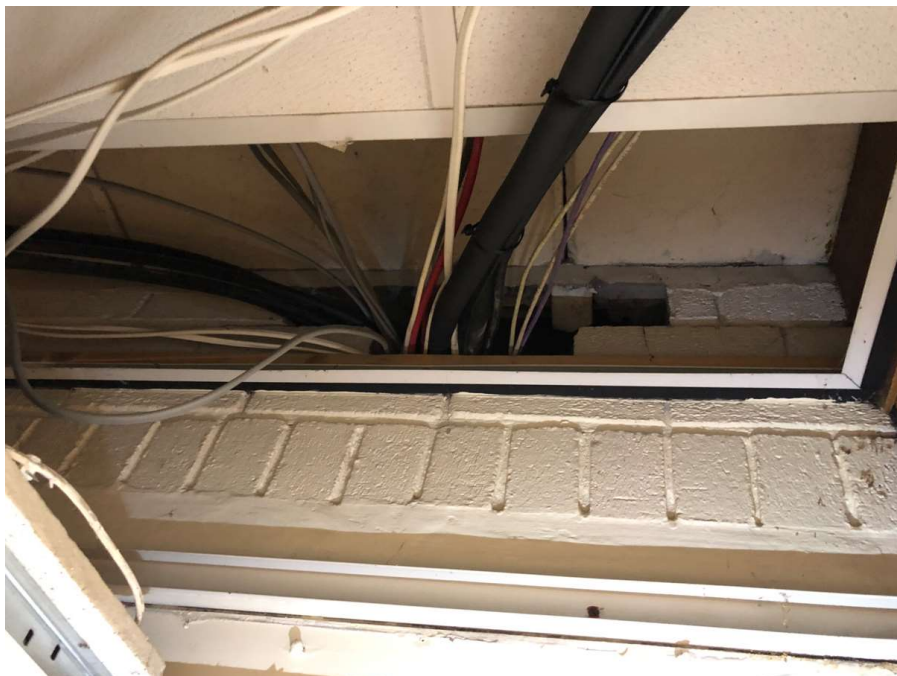
Photo 53: Lack of support to RAAC roof panel above corridor caused when service penetrations were made through the brickwork wall at high level. Urgent remedial is work required to reinstate adequate support and prevent failure of the panel.

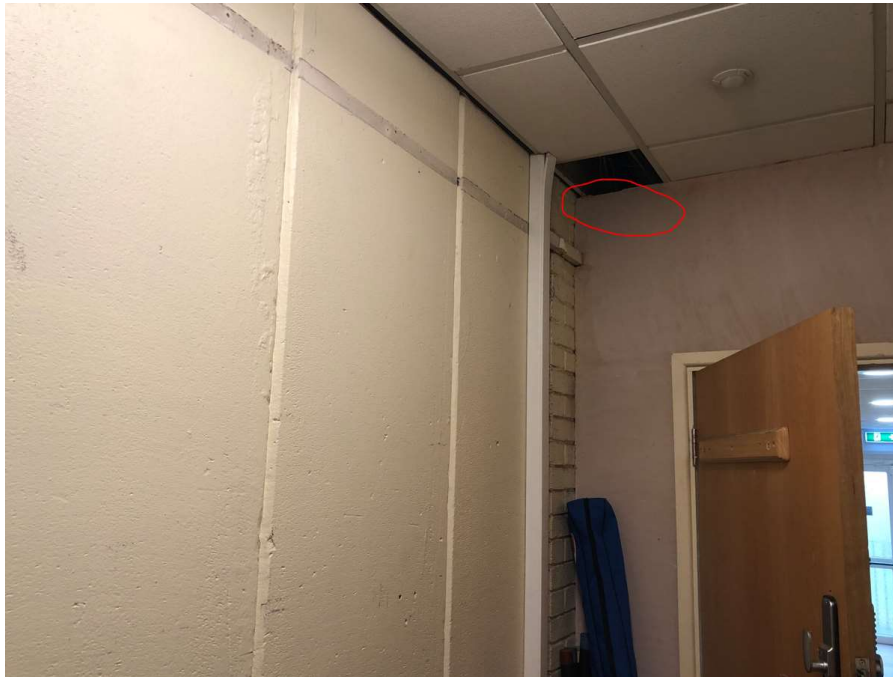
Photo 54: View in storeroom. Vertical RAAC wall panels built in circa 1980 abut the earlier brickwork wall of the 1970s building. The area circled in red is where the RAAC panel has insufficient bearing (photo 53).

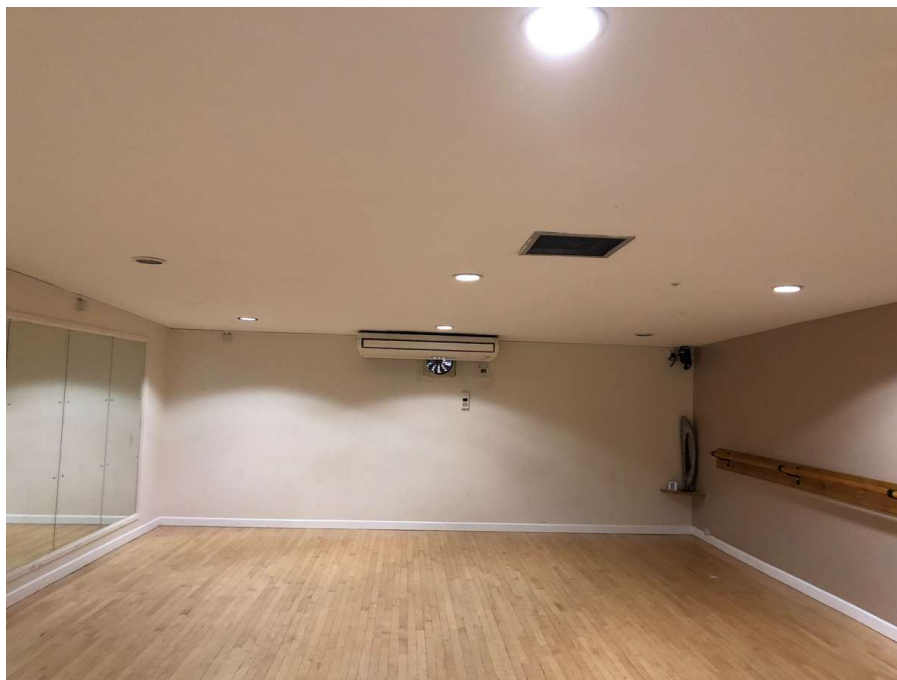
Photo 55: Internal view of dance studio at first floor. There are RAAC panels above the solid plastered ceiling. Condition of RAAC unknown.

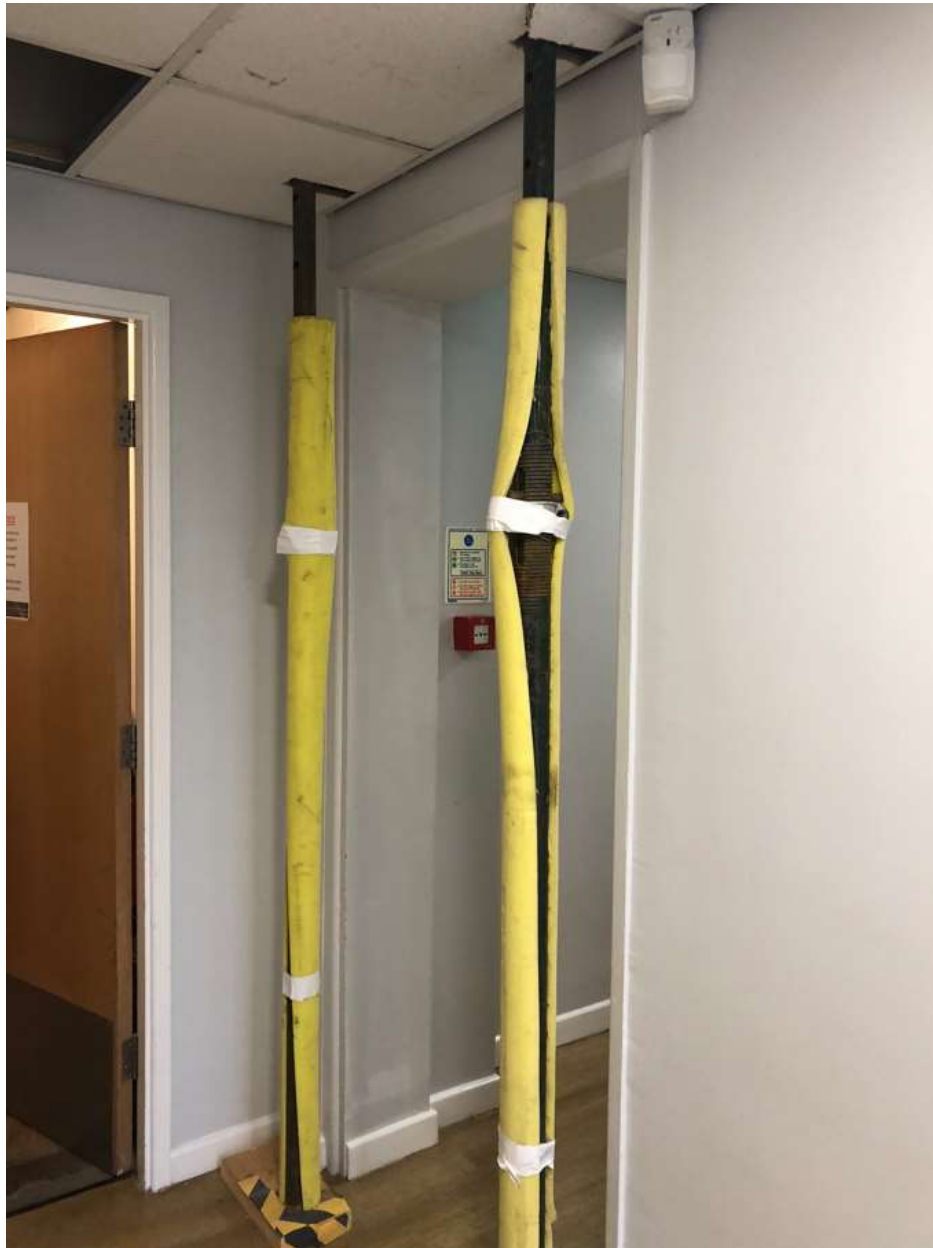
Photo 55: Since our original survey the RAAC panel has been temporarily propped as a short term 'make safe' precaution.
