Building survey report

**51 Ilkeston Road,
Bramcote, Nottingham,
NG9 3JP**

Prepared for: Broxtowe Borough Council
Prepared by: [REDACTED] BSc (Hons) MSc MRICS
[REDACTED] BA (Hons) MSc
Date: 05 February 2024
Reference: ST24.003

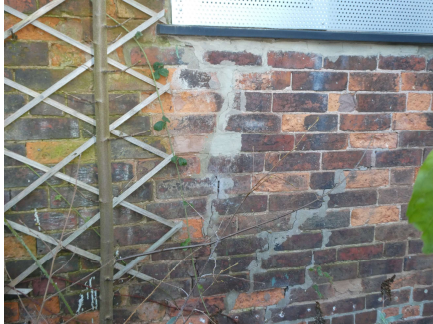
- 2.2.4. The superstructure comprises of solid brick wall construction. We expect the construction to be load bearing solid brickwork laid in traditional Flemish bond formation, with assumed no insulation. As mentioned above, significant structural cracking was noted to the rear elevation spanning the full height of the elevation, and additional areas of stepped cracking were noted to the front and rear elevations, above the ground floor window openings. As such, and further to the repair and repointing works, it is recommended that all noted defects are monitored moving forward, and if deemed necessary, further investigations be undertaken by a Structural Engineer.

View of the cracking to the rear elevation external brickwork at low level.

- 1) Monitor the cracking noted to front, left hand side, and rear elevation brickwork following repointing and repair works.
- 2) Dependant on the outcome of the recommended monitoring works, commission further specialist investigations into the suspected historic subsidence to the rear left hand side corner of the property.

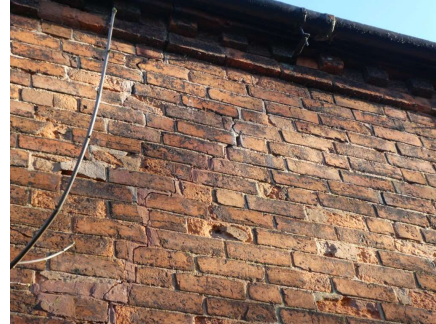
View of the cracking to the rear elevation external brickwork at high level.

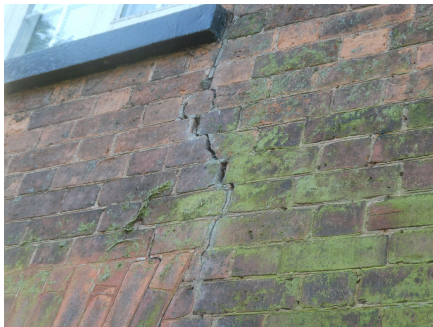
View of stepped cracking above the front elevation ground floor window.

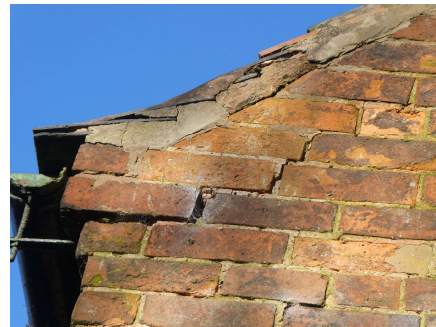
- 2.2.5. In addition to the above, further stepped cracking and distorted brickwork was noted to the high level gable end to the left hand side elevation, indicative of roof spread. Roof spread is caused by the downward pressure of the roof covering, resulting in the downwards movement of the rafters and subsequent outwards movement of the brickwork. Therefore, it would be prudent to commission a structural engineers survey to ascertain the condition and stability of the roof structure, with any recommendations for remedial works being undertaken in the short term. This may include the installation of additional beams and struts within the roof structure, to provide stability and strength.

View of the cracked and distorted brickwork to the high level gable end.

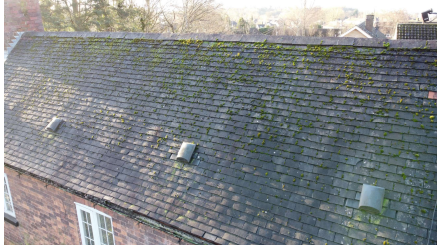
View of the slate roof covering to the main building.

- 2.3.4. Overall, and despite no evidence of recent internal rainwater ingress being noted, the main roof covering is in poor condition commensurate with its age. Generally, the tiled surfaces are soiled and stained with detritus and moss growth and numerous slate tiles are slipped, cracked, and part missing, allowing daylight into the internal roof space. The mortar bed to the slate ridge tiles is heavily degraded and cracked and isolated ridge tiles appear loose. In addition, the mortar pointing to the masonry constructed chimney stacks is generally part missing and degraded and the flaunching to the crown is cracked and subject to heavy moss growth.

- 2.3.5. In the immediate to short term, and in the interest of mitigating future more costly repairs and overcoming any health & safety concerns, we would recommend that a package of targeted roof repair works be completed to include localised replacement of slipped and part missing roof tiles and renewal of mortar bedding, flaunching, and pointing to chimney stacks. Considering the age and condition of the roof covering as a whole, including the 'at risk' structural roof members, full roof covering replacement works are likely to become necessary in the medium to long term, albeit it is likely to be more cost effective to complete such works as part of a single works package in the immediate term.

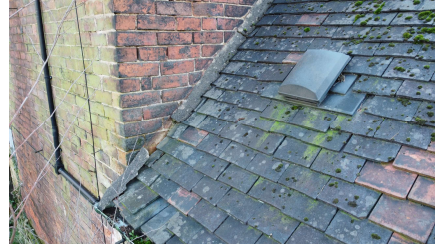
View of cracked and part missing mortar to the flashing abutment.

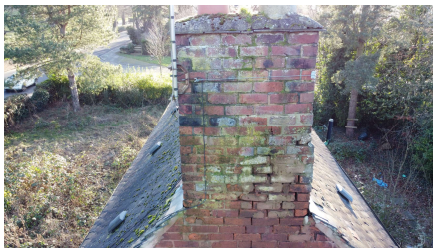
View of degraded and part missing mortar pointing to the chimney stack.

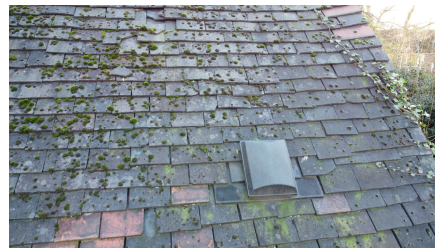
- 2.3.3. The roof to the rear kitchen is also formed of a traditional cut timber pitched roof design and is weathered externally with natural slate roof and ridge tiles which appeared in poor condition. The slate roof tiles are cracked, slipped, and missing in numerous locations, no lead flashings are present to the abutment where the roof meets the rear elevation of the main structure, and moisture readings were taken at several locations to the timber which all indicated a wet, saturated, and 'at risk,' roof structure. In addition, the cement mortar installed to the abutment of the rear elevation is heavily cracked, degraded, and part missing and the plasterboard ceiling soffit to the kitchen has collapsed, which we presume is a direct result of water ingress.

View of numerous cracked, slipped, and part missing roof tiles to the kitchen roof.

- 2.3.6. To the kitchen roof, given the extent of disrepair noted both externally and internally, full roof replacement works are recommended, which should include the replacement of any decayed and damaged structural roof members, the installation of new lead flashings, and the replacement of the slate roof covering in its entirety, in the immediate term.

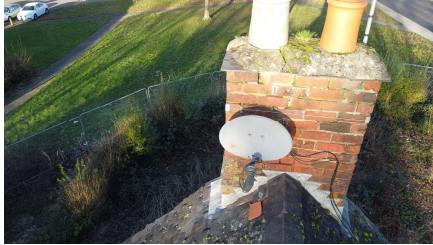
View of cracked and heavily soiled mortar flaunching to the chimney stack.

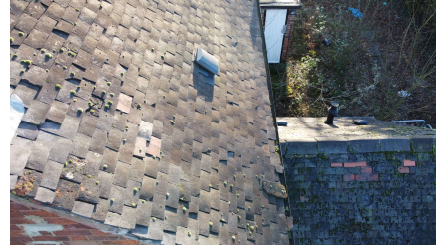
Further view of slipped and part missing slate roof tiles to the main building.

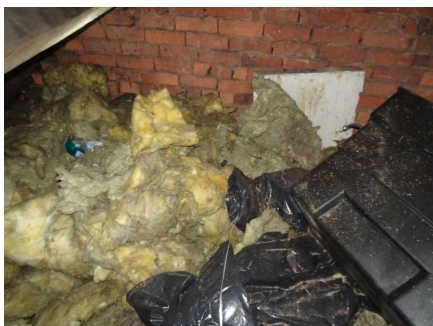
- 2.3.7. Within the main roof void, the insulation is installed between the first floor ceiling joists. Generally, and from our limited inspection, the roof void insulation was in poor condition and poorly installed. Numerous areas were part missing, torn, and unevenly distributed throughout the roof. You may, therefore, find it beneficial to renew the insulation as part of the recommended roof works package. The roof was well ventilated via externally mounted roof vents, positioned uniformly. Notwithstanding, widespread dampness and high moisture readings were visually evident throughout the roof structure which we suspect is entering through the deteriorated roof covering.

View of damaged insulation.

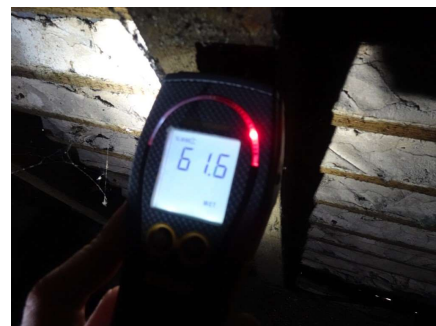
- 2.3.1. The main roof benefits from a traditional cut timber pitched roof, consisting of a ridge board, common rafters, and timber purlins. A breathable sarking felt membrane was noted to be absent at the time of inspection, which revealed multiple areas of daylight appearing through the natural slate roof covering. Whilst no water ingress was noted, moisture meter readings were taken at several locations which all indicated a wet, saturated and 'at risk' roof structure.

View of moisture meter reading indicating a saturated 'wet' condition.

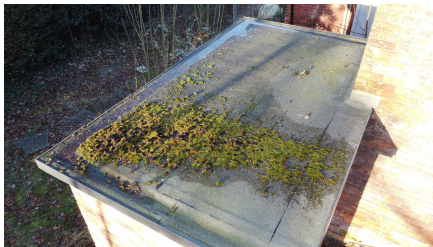
- 2.3.8. The flat roof to the outbuilding is weathered with a mineral felt roof covering, laid on a suspected timber deck and supported by timber joists. The felt covering is soiled with heavy moss and vegetation growth, and the felt is blistering and bubbling in isolated locations, indicating moisture/air pockets trapped between the felt and the roof deck. In addition, standing water is present to the gutter runs, which are generally soiled and blocked with debris and

vegetation. Unfortunately, no internal access was available into the outbuilding and, therefore, we cannot comment on the presence of any internal water ingress. Notwithstanding, we anticipate the roof covering to be nearing the end of its economic life and, therefore, consideration should be given to full replacement in the medium term.

View of mineral felt roof covering to the outbuilding.

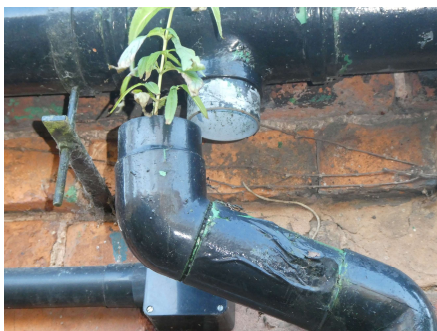
- 2.3.11. Generally, the rainwater goods are in fair condition, however, we noted a build-up of detritus, vegetation, and leaves to the gutters runs. In addition, the cast iron gutter to the rear elevation roof pitch is corroded in numerous areas, isolated metal fixing brackets are part missing and detached from the elevation brickwork, and the painted finish to all rainwater goods is delaminated, part missing, and faded. To the kitchen roof, the right hand side downpipe is detached from the gutter run and the guttering is bowed centrally.
- 2.3.12. To the outbuilding, the flat roof is laid to fall towards the drainage runs which are incorporated into the perimeter of the flat roof, connected to elevation mounted PVCu downpipes. The drainage runs are generally soiled and blocked with debris and vegetation and standing water is present throughout.

View of the disconnected downpipe to the kitchen roof.

- 2.3.13. With a view to achieving economies of scale and taking advantage of high level access equipment, it is recommended that the rainwater goods are overhauled, redecorated, and cleared during the roof covering replacement works noted above. Consideration may be given to replacement of the cast iron gutters, which are heavily corroded and damaged. External drainage gulleys should also be cleared in the immediate term and on a cyclical basis thereafter.

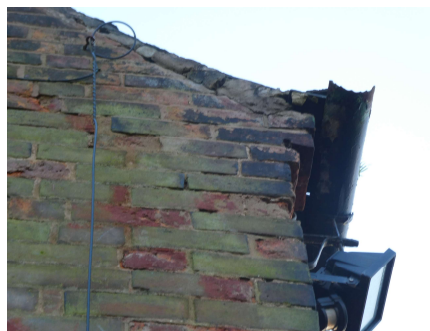
View of corroded and part missing cast iron gutter.

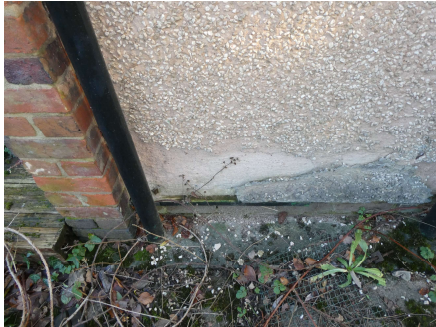
- 2.3.16. The loadbearing masonry walls to the house and outbuilding are generally in a poor to fair condition commensurate with their age. Surfaces were noted to be soiled and stained throughout with moss, vegetation, and ivy growth present in numerous locations. In addition, the brickwork is cracked, spalled, and otherwise damaged and the mortar pointing is part missing and degraded in several locations. Areas of stepped cracking is also present to the front elevation, and additional cracking is present to the rear elevation, spanning the full height of the brickwork, as mentioned within section 2.2 above. Furthermore, the rendered coatings to the outbuilding elevations are cracked, impact damaged, and part missing.

View of the cracked and part missing pebbledash rendered coating.

- 2.3.18. In the short term, we would recommend that a package of targeted brickwork repairs be completed to include localised replacement of spalled and damaged bricks, renewal of degraded mortar pointing, and restorative cleaning works to remove all surface soiling, staining, and vegetation.

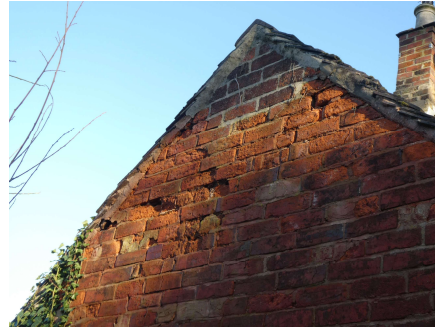
View of spalled and cracked brickwork and degraded mortar pointing.

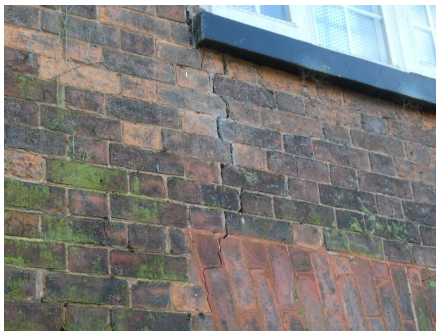
View of stepped cracking to front elevation between the dining room and bedroom window.

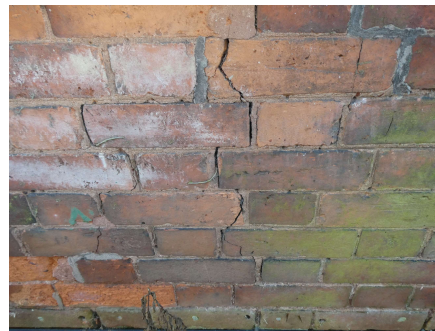
View of the stepped cracking below the living room window.

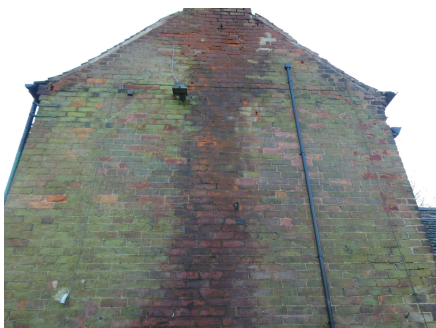
- 2.3.17. In addition to the above, we also noted the presence of widespread damp staining to the right hand side elevation which corresponds with the internal location of the chimney breasts to the dining room area. We suspect the damp staining is likely to be caused by water ingress via the roof level open chimney pots. Given the property has stood vacant for a prolonged period of time, with the open fires not being in use, this is also likely to have contributed to the dampness and, therefore, it is recommended that the damp staining be monitored moving forward, and if necessary, internal air vents be installed at first floor level to promote ventilation of the chimney breasts.

View of damp staining to the right hand side elevation brickwork.

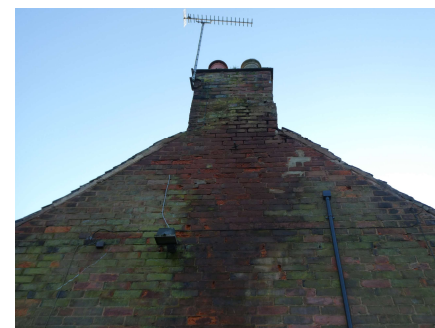
Further view of damp staining to the right hand side elevation brickwork at high level.

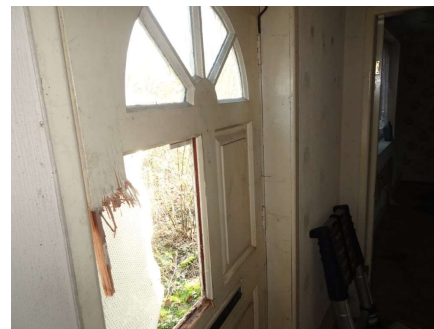
- 2.3.20. The main entrance door comprises a painted single leaf timber doorset, which is heavily weathered, decayed, and impact damaged, and has subsequently been boarded over with metal sheeting. To the rear kitchen, an additional timber door is provided, however, again this is heavily damaged, weathered, and part missing, and a metal security door has been installed to the external brickwork. It is, therefore, recommended that as part of the short term refurbishment works both doorsets are replaced.

View of the damaged and part missing front entrance door.

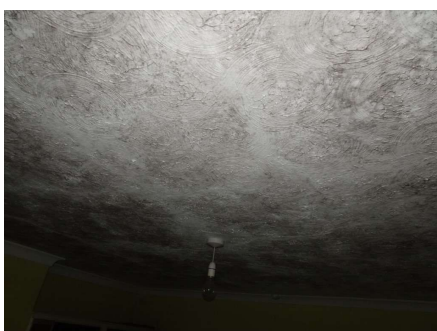
- 2.4.3. Ceilings throughout the property comprise a combination of painted plaster, woodchip, and Artex ceiling finishes, albeit a decorative covering is provided to the ceilings within the living room and pantry areas. In addition, decorated faux timber beams are installed to the ceilings within the ground floor living and dining room areas. Generally, the ceilings remain in a poor condition, particularly to the kitchen area where the ceiling has collapsed from presumed heavy water ingress. Ceilings to the first floor area are generally uneven, bowed, and cracked, and large amounts of mould growth and damp staining is evident throughout. In addition, where evident, the decorative coverings are part missing and damaged, and the ceilings are impact damaged and part missing in isolated areas. Given the condition of the ceilings, and the potential for asbestos containing materials to be present within the Artex, it is recommend that an Asbestos survey is undertaken in the immediate term, subsequent to which, all ceilings should be replaced throughout the property.

View of the mould growth and bowed ceiling to the first floor bedroom..

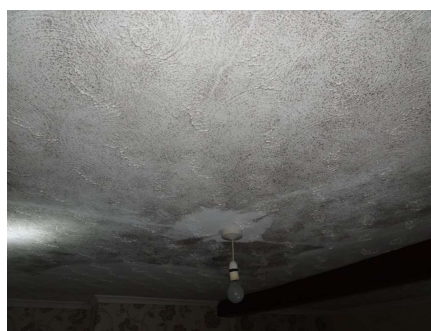
View of cracking to the first floor bedroom ceiling.

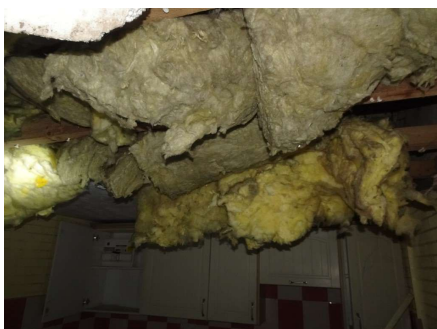
View of the collapsed kitchen ceiling.

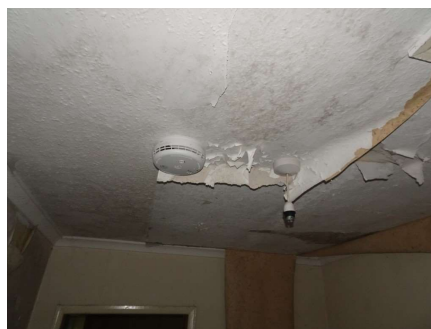
View of delaminated decorative ceiling covering to the landing area.

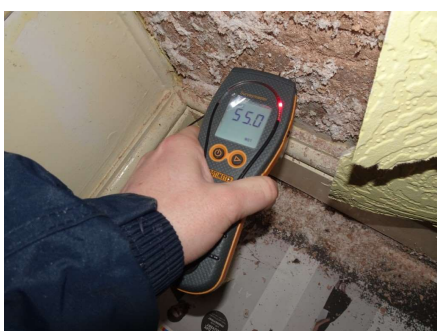
- 2.4.4. The internal walls throughout the property comprise of load bearing brickwork, all of which are finished with painted plastered walls, which in many instances, has been covered with decorative wall coverings. The decorative coverings and plasterwork are in poor condition. High levels of moisture and mould growth are evident in numerous locations, the plasterwork is cracked, uneven, and crumbling in several areas, and the decorative wall coverings are peeling, bubbled, and part missing throughout. It is anticipated that following the removal of the decorative wall coverings, all of the plasterwork will require renewal to provide a consistent and uniform finish, in preparation for redecoration works.

View of moisture meter reading indicating a saturated 'wet' condition.

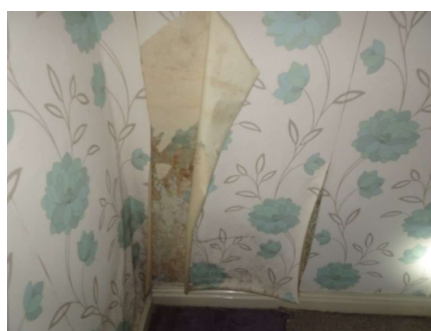
View of peeling and bubbled decorative wallpaper covering.

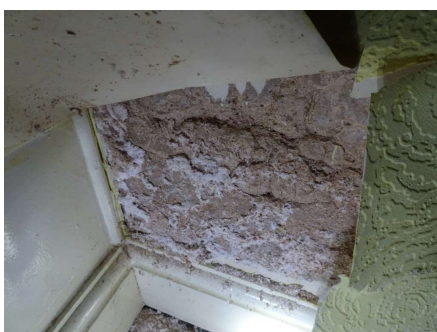
View of cracked, crumbling, and damaged plasterwork to the first floor bedroom.

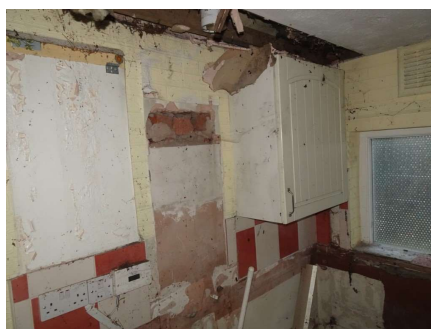
View of the damaged plasterwork to the kitchen area.

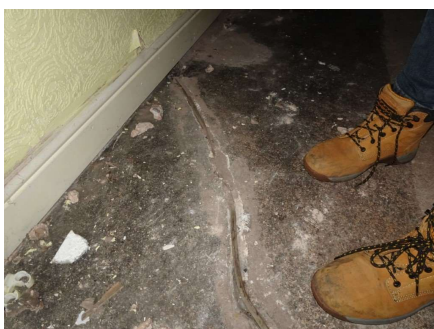
- 2.4.5. Floor coverings at first floor level comprise carpet floor coverings to the bedrooms, landing and staircase areas, and a laminate floor to the family bathroom. At ground floor level, carpet floor coverings are provided to the living room, wood effect laminate flooring is provided to the dining room, entrance hallway, and pantry, and ceramic floor tiles are provided to the kitchen. Generally, the floor coverings provided throughout the property are in poor condition. The carpet floor coverings are heavily soiled, stained, trafficked, and worn, and the laminate flooring is heavily scratched, marked, and soiled. In addition, the ceramic tiled floor covering to the kitchen are generally soiled, marked, and scratched, albeit a large majority of the flooring was concealed from view due to the debris from the collapsed ceiling. In addition, the concrete screed installed to the first floor area is also cracked and spalled in isolated locations. Where the carpet is part missing, the exposed timber floor boards are present and when tested with a damp meter, the suspended timber floor boards were showing elevated 'at risk' meter readings in isolated locations. Given the high moisture content within the property and the elevated readings, once the floor coverings are removed, additional timber repair/replacement works may be required to the floor boards, subject to the condition and evidence of decay.

View of cracked floor screed to the first floor bedroom.

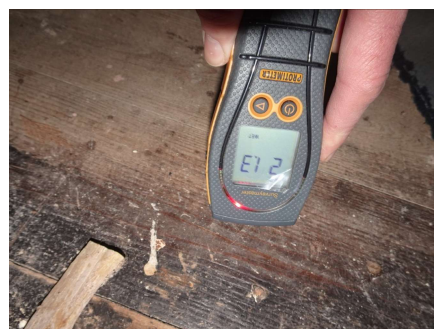
- 2.2.2. The ground floor construction to the building comprises suspended timber floor construction with assumed strip or trench fill concrete foundations (intrusive inspection would be required to confirm this). Moisture meter readings were taken at several locations to the suspended timber floor which all indicated a wet, saturated and 'at risk' floor structure. As such, it may be prudent to commission a timber survey to ascertain the condition and structural adequacy of the timber floor boards and provide information on whether any remedial works are required.

View of moisture meter reading to the ground floor, floor boards indicating a saturated 'wet' condition.

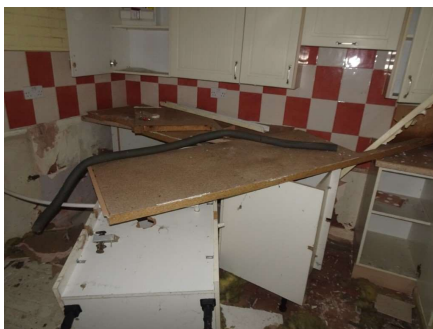
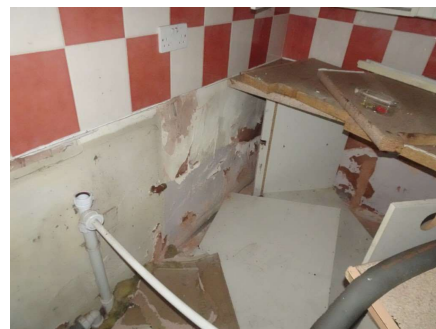
- 2.4.8. The kitchen, which is accessed off the dining room area, is in a poor state of disrepair. As mentioned above, the plasterboard ceiling is collapsed, numerous kitchen units are damaged, and a large majority of appliances (cooker, sink, fridge etc.) are missing. As such, full kitchen refurbishment works are required in the immediate term.

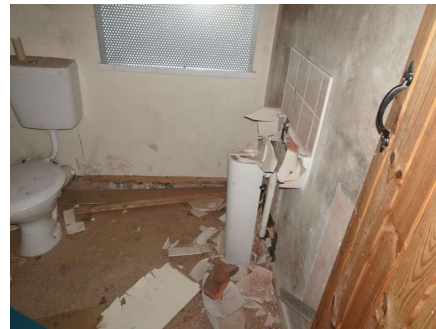
- 2.4.10. At first floor level, a bathroom is accessible from the landing and incorporates a bath with fitted side panels, a ceramic WC, and a ceramic wash hand basin. The perimeter walls are a combination of ceramic wall tiles and plastered walls. The bathroom is in poor condition. The wash hand basin has been vandalised and is heavily damaged, the WC pan is soiled, scratched, and marked, and the side panel to bath is cracked and part missing. In addition, surfaces are generally soiled and stained throughout and mould growth is present to surfaces. As such, full bathroom refurbishment works, inclusive of new fixtures, fittings, and sanitaryware, are required in the immediate term.

View of damaged wash hand basin.

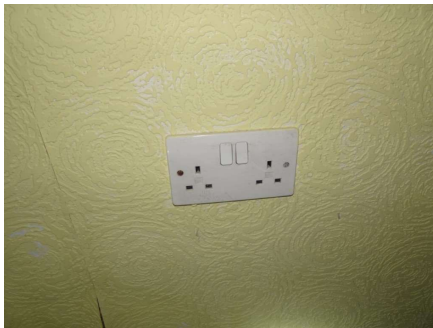
- 2.5.13. Electrical sockets are provided throughout the property in the form of recessed and surface mounted double and single sockets. All small power installations appear in fair visual condition, however, no electrical supply is currently provided to the property, therefore, we cannot confirm the operational condition of the electrical systems.
- 2.5.14. Whilst there currently appears to be adequate provision in each room for sockets, your intentions for the property may warrant additional sockets and an increased electrical supply, meaning potential re-wiring works may be required. To this end, it is recommended that the wiring systems are inspection by a qualified electrician to understand their age and suitability for meeting your plans for the property.

View of dated socket face plate to the first floor areas.

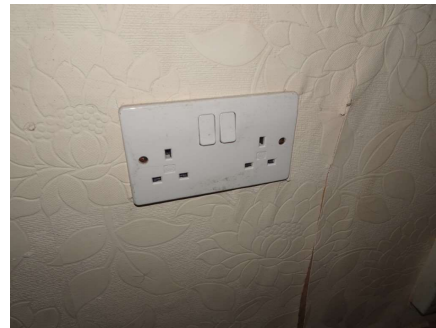
View of dated socket face plate to the ground floor areas.
