## Section 4 – Action Plan

### 4.1 - ACTION TABLE

### Appendix 4

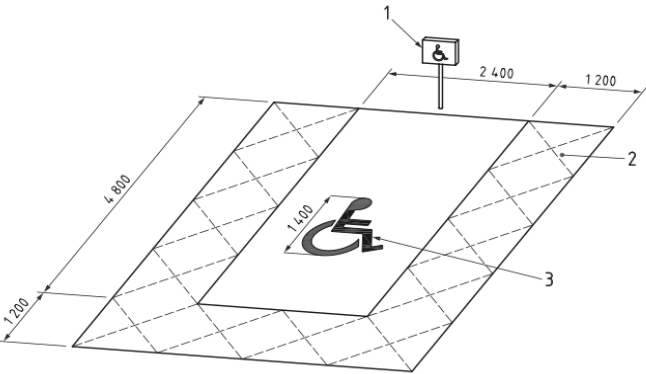
2.2	<p style="text-align: center;">Dimensions in millimetres</p>

2.2	<p>Accessible bays are not signposted on entrances, but positioned immediately by the entrances. Museum logo on parking sign for short stay car park partially obscured with directional signage. There is no signage at the front of the bays.</p>	<p>Liaison should be undertaken with the relevant department in the Local Authority to highlight the issue.</p> <p>Refer to diagram for best practice BS8300 specification.</p>	N

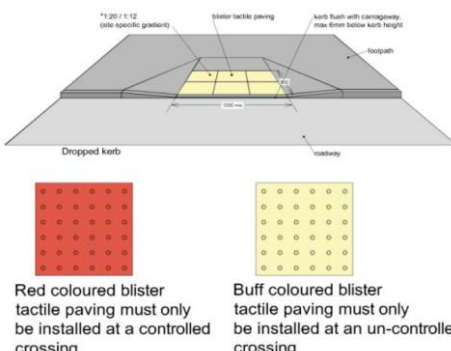
<p>2.3</p>	<p>Long stay car park, bay 1, has hatched area on one side and rear only and there appears to be cafe waste at the front of the bay. At the opposite end of the car park a further accessible bay (28) is hatched on one side and rear only.</p> <p>Short stay car park accessible bays have hatching on each side/enough space for drivers or passengers to transfer, though no dropped kerb on pavement next to bay in front of parking sign.</p>	<p>Liaison should be undertaken with the relevant department in the Local Authority to highlight the issue.</p> <p>Refer to diagram for best practice BS8300 specification.</p>	<p>N</p>	
<p>2.5</p>	<p>Dropped kerbs are provided, but no tactile paving. Car park surface is smooth.</p>

<p>Site management should undertake liaison with the Highways Dept to provide tactile paving in the area to aid people with impaired vision.</p> <p>Refer to diagram for specification.</p>	<p>N</p>

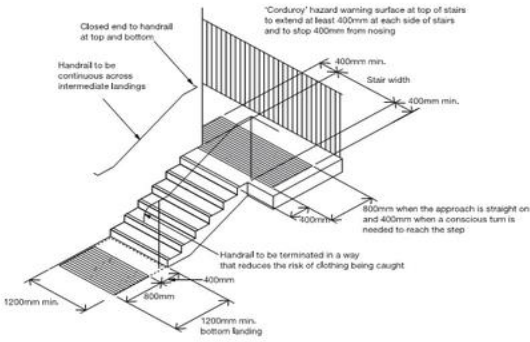
<p>4.1</p>	<p>There are no visual or tactile warnings at the top and bottom of steps leading to museum garden and picnic area.</p>	<p>Install tactile paving to both the top and bottom of steps.</p> <p>BS8300 - To give advance warning of a step, tactile paving with a corduroy hazard warning surface should be provided at the top and bottom of each flight, excluding intermediate landings with continuous handrails. Where the approach to the stair is wider than the flight, the tactile surface should extend beyond the line of each edge of the flight.</p> <p>Refer to diagram for specification.</p>	<p>M</p>	
<p>4.1</p>

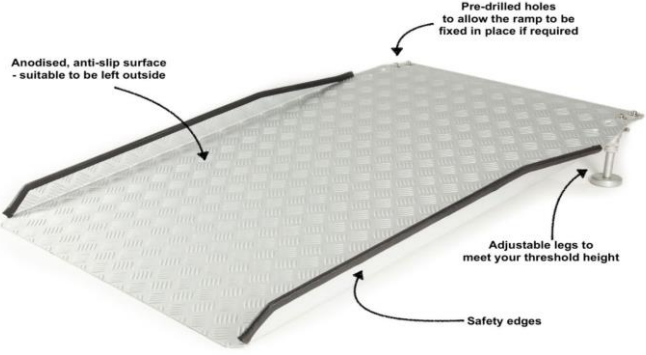
<p>5.3</p>	<p>No level threshold provided, one step with portable ramp available for staff to manage visitor entry. Internally the step is not flush with reception flooring.</p> <p>Staff confirm that as museum entrance from street is on a slope a portable ramp for one side of a wheelchair is provided. Nosings are absent from the entrance step.</p>	<p>Remedial works should be undertaken to the threshold to ensure a flush entrance threshold is provided that eliminates the cross-all gradient at the entrance. This will aid wheelchair users as well as remove a potential tripping hazard.</p> <p>In the short term an improved bespoke portable ramp to be provided that will take into account the sloped entrance and to cover the full width of a wheelchair. An Adjustable Threshold Bridge Ramp may offer a suitable solution to accommodate the uneven threshold height.</p> <p>Bright colour contrast to be painted to the edge of the step nosing to clearly highlight its presence.</p>
