Report of the Portfolio Holder for Environment and Climate Change

REPLACEMENT OPTIONS FOR BRINSLEY HEADSTOCKS1. Purpose of Report

Brinsley Headstocks Photographs

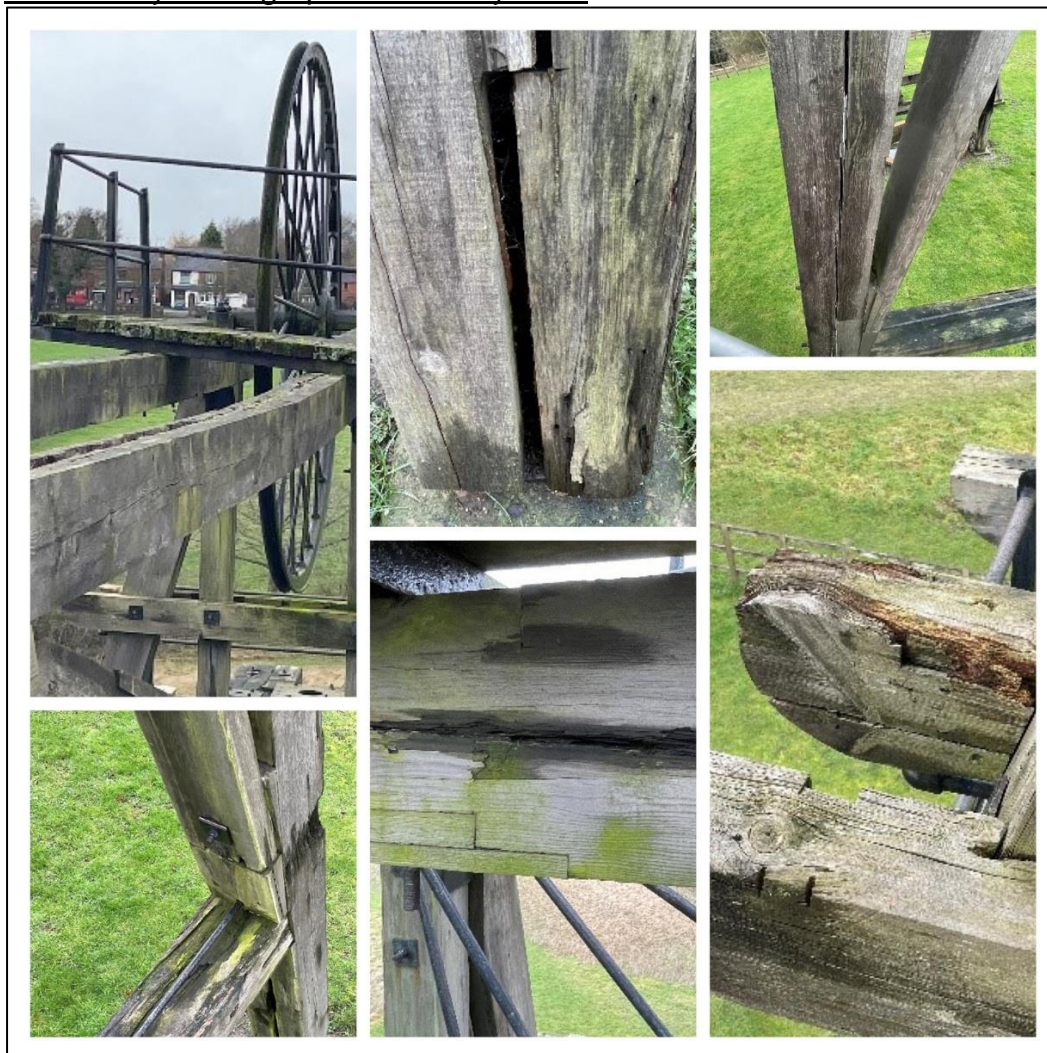
Site Survey Photographs – January 2023

In January 2023, a condition report and safety inspection was undertaken on the Headstocks. It identified that the Headstocks were no longer considered capable of safely carrying the load from the winding wheels without intervention.

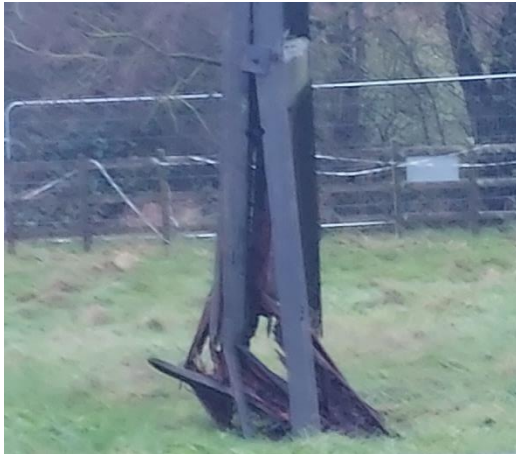
Headstocks deterioration- November 2023

Central trestle leg of the Headstocks, highlighting significant deterioration. This was picked up during a routine structural condition check by employees.

The collapsed leg was pulling and twisting the Headstocks structure towards the public benches.

At the beginning of September 2023, the metal colliery wheels were removed, in the hope that the timbers from the towers could be salvaged. However, in late November employees undertaking checks on the structure noted further deterioration in the wooden structure. This was confirmed by an appropriately qualified employee and concerns were raised that the structure was at risk of imminent collapse.

Given the level of deterioration, restoration of the structure, as it currently stood was no longer possible and in the interest of public safety, the most appropriate

course of action was to have the Headstocks dismantled. This was undertaken in December 2023.

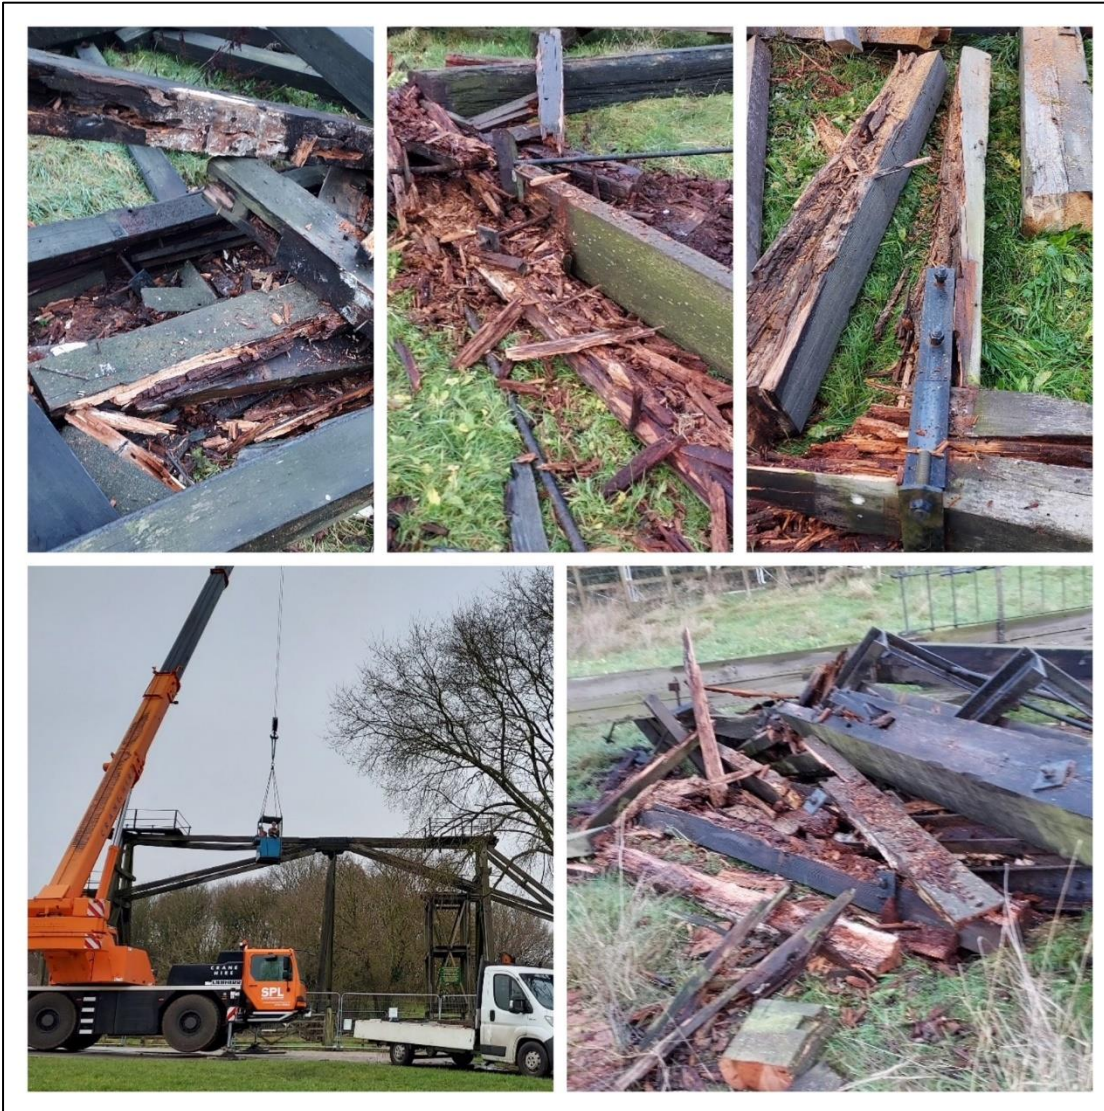
Dismantling of the Headstocks

During the dismantling process, a thorough assessment of the timbers was made. Unfortunately, the majority of these were found to be in poor condition (Photos highlighting this are in **APPENDIX 2**), rendering them unsalvageable. All the metal work was retained and taken to Kimberley depot for storage.

As highlighted earlier in the report, further deterioration in the wooden structure was identified in November and a decision was taken to dismantle the Headstocks in the interest of public safety. This has been at a cost of £28,000. The details of this are contained in table 2.
