Building survey report

**51 Ilkeston Road,
Bramcote, Nottingham,
NG9 3JP**

Prepared for: Broxtowe Borough Council
Prepared by: [REDACTED] BSc (Hons) MSc MRICS
[REDACTED] BA (Hons) MSc
Date: 05 February 2024
Reference: ST24.003

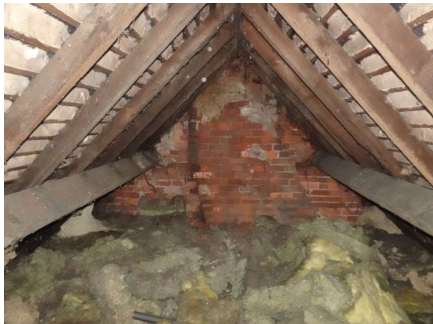
- 2.3.7. Within the main roof void, the insulation is installed between the first floor ceiling joists. Generally, and from our limited inspection, the roof void insulation was in poor condition and poorly installed. Numerous areas were part missing, torn, and unevenly distributed throughout the roof. You may, therefore, find it beneficial to renew the insulation as part of the recommended roof works package. The roof was well ventilated via externally mounted roof vents, positioned uniformly. Notwithstanding, widespread dampness and high moisture readings were visually evident throughout the roof structure which we suspect is entering through the deteriorated roof covering.

View of the roof void.

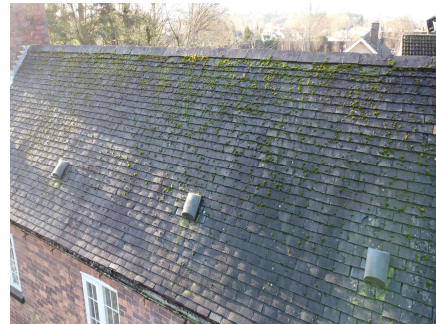
View of the roof vents.

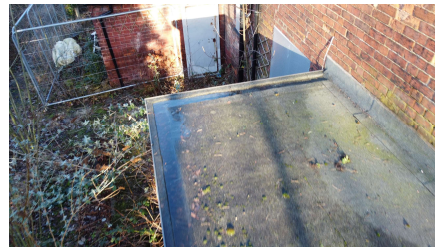
- 2.3.8. The flat roof to the outbuilding is weathered with a mineral felt roof covering, laid on a suspected timber deck and supported by timber joists. The felt covering is soiled with heavy moss and vegetation growth, and the felt is blistering and bubbling in isolated locations, indicating moisture/air pockets trapped between the felt and the roof deck. In addition, standing water is present to the gutter runs, which are generally soiled and blocked with debris and

vegetation. Unfortunately, no internal access was available into the outbuilding and, therefore, we cannot comment on the presence of any internal water ingress. Notwithstanding, we anticipate the roof covering to be nearing the end of its economic life and, therefore, consideration should be given to full replacement in the medium term.

View of blistering to the mineral felt roof covering.

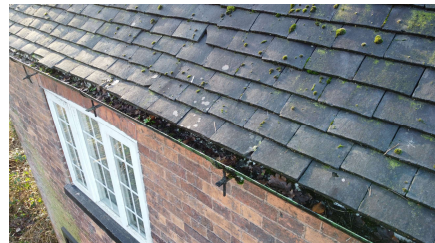
View of the PVCu rainwater goods to the front elevation.

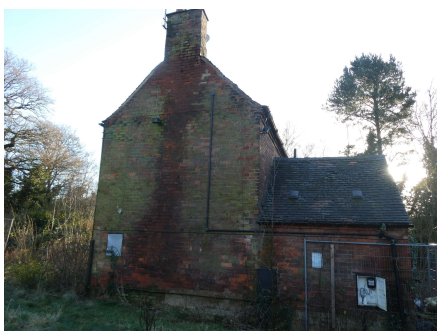
View of elevation brickwork.

- 2.3.16. The loadbearing masonry walls to the house and outbuilding are generally in a poor to fair condition commensurate with their age. Surfaces were noted to be soiled and stained throughout with moss, vegetation, and ivy growth present in numerous locations. In addition, the brickwork is cracked, spalled, and otherwise damaged and the mortar pointing is part missing and degraded in several locations. Areas of stepped cracking is also present to the front elevation, and additional cracking is present to the rear elevation, spanning the full height of the brickwork, as mentioned within section 2.2 above. Furthermore, the rendered coatings to the outbuilding elevations are cracked, impact damaged, and part missing.

- 2.3.18. In the short term, we would recommend that a package of targeted brickwork repairs be completed to include localised replacement of spalled and damaged bricks, renewal of degraded mortar pointing, and restorative cleaning works to remove all surface soiling, staining, and vegetation.

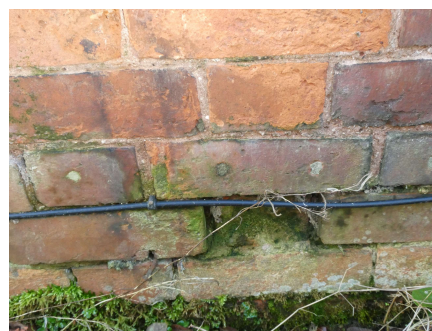
- 2.3.14. The external elevations are formed of traditionally constructed load bearing solid wall construction. Although no intrusive inspection has been undertaken, it is assumed that the solid brick walls to the structure are absent from any internal insulation and therefore, any insulation at all. We also assume that the outbuilding to the rear of the property is constructed of solid brick construction, which is provided with areas of pebble dash rendering to the rear and right hand side elevations. The presence of a chemical damp proof course is installed at low level throughout the perimeter elevations of the property which is visible to the low level brickwork.

View of chemical damp proof course to the low level masonry brickwork.

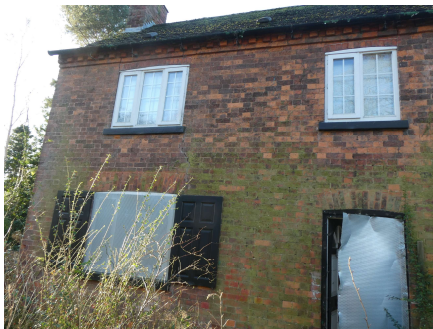
- 2.3.19. The fenestration throughout the property comprises double glazed timber framed casement windows, however, the timber windows to the ground floor are currently boarded up with metal security sheeting, given the unoccupied nature of the property. Notwithstanding, where visible, the windows are in a fair to good condition commensurate with their age, albeit the timber frames and glazing are generally soiled, marked, and stained. As such, surfaces should be cleaned in the short term to restore their appearance, and the windows would benefit from general overhauling works in the medium term, including easing and adjusting the moving parts, isolated timber repairs, renewal of mastic sealant, and redecoration works.

View of the front elevation windows.

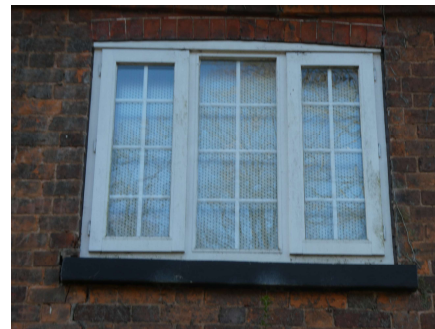
View of typical timber window installation.

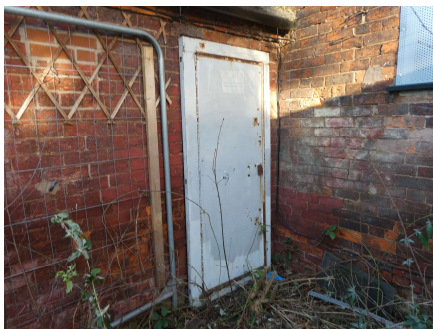
- 2.3.20. The main entrance door comprises a painted single leaf timber doorset, which is heavily weathered, decayed, and impact damaged, and has subsequently been boarded over with metal sheeting. To the rear kitchen, an additional timber door is provided, however, again this is heavily damaged, weathered, and part missing, and a metal security door has been installed to the external brickwork. It is, therefore, recommended that as part of the short term refurbishment works both doorsets are replaced.

View of the metal security door installed to the brickwork in front of the kitchen door.

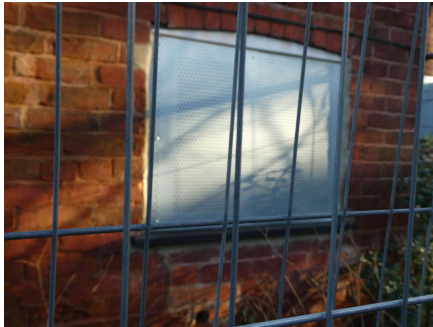
View of typical metal sheeting installed to the face of the ground floor windows.

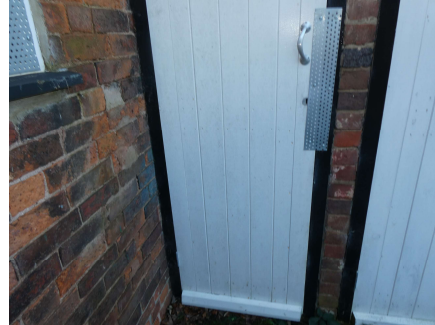
- 2.3.21. To the outbuilding, 2 no. timber doors are provided to the left hand side elevation. These are generally in fair condition, albeit surfaces are soiled and marked, and isolated decay and

damage was noted at low level. Therefore, it is anticipated that isolated repair and redecoration works will be required in the medium term, alongside overhauling of the ironmongery.

View of the timber door to the outbuilding.

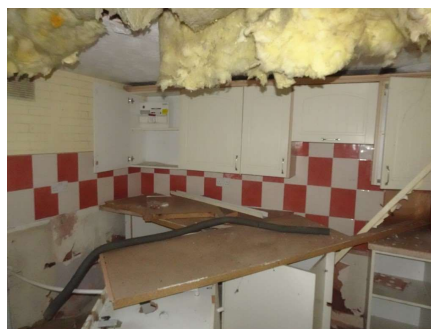
Kitchen accommodation.

- 2.4.8. The kitchen, which is accessed off the dining room area, is in a poor state of disrepair. As mentioned above, the plasterboard ceiling is collapsed, numerous kitchen units are damaged, and a large majority of appliances (cooker, sink, fridge etc.) are missing. As such, full kitchen refurbishment works are required in the immediate term.

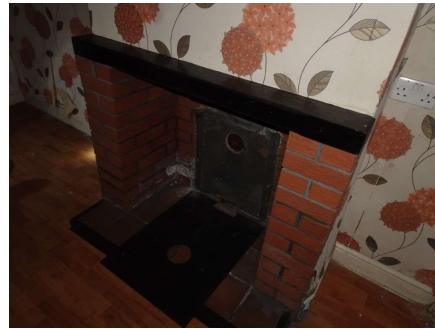
View of the redundant fireplace to the dining room.

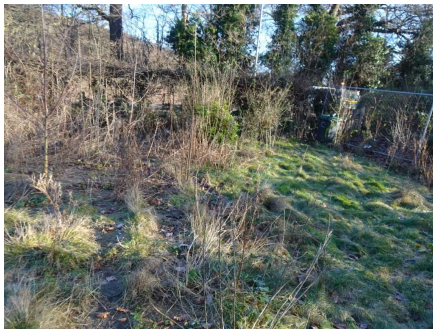
View of the concrete paving slab to the North of the site.

- 4.1.2. The concrete paved patio and perimeter footpaths are generally in poor condition. Surfaces are uneven, isolated paving slabs are cracked and damaged, and unwanted debris and vegetation is present to the joints. As such, it is recommended that all concrete paved patio and footpath areas are lifted and relaid in the short term. In addition, to the rear of the property, a small area of built up timber decking is provided, which is subject to heavy moss growth and is generally weathered and decayed. Subject to your plans for the property, the timber decking should either be removed or renewed in the short to medium term.
- 4.1.3. The site is enclosed with a combination of wire mesh fencing and perimeter hedge growth. The wire mesh fencing is in poor condition, with numerous sections missing and damage and corrosion noted throughout.

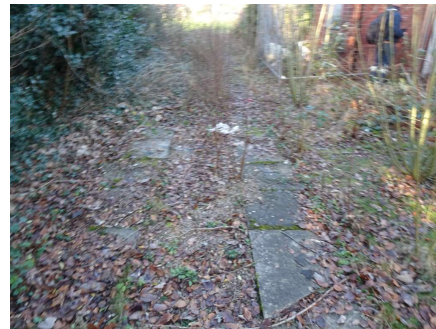
View of the concrete paved footpath.

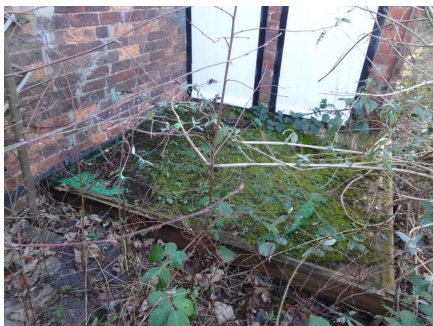
View of the rear timber decking.

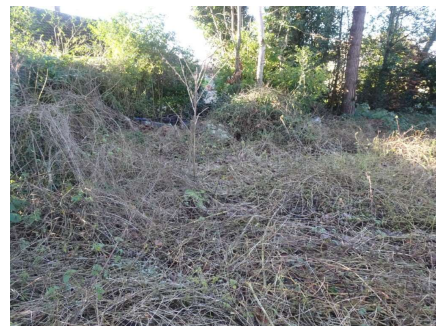
View of general overgrown garden areas.

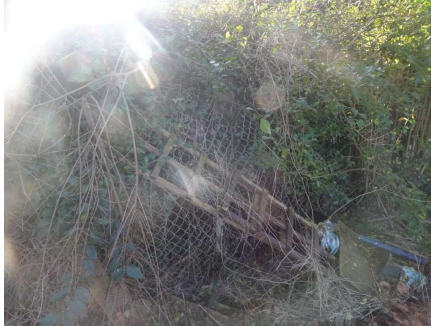
View of the wire mesh fencing.

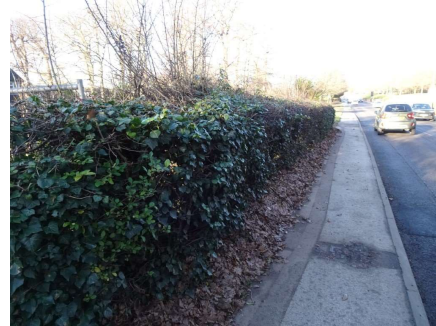
View of the hedgerows to the site boundary.

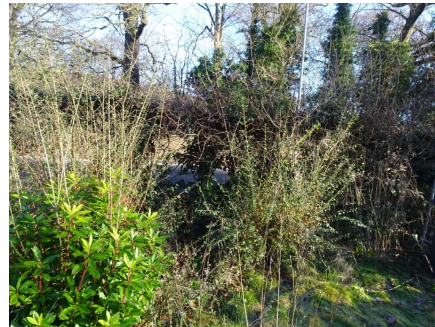
View of overgrown perimeter boundary hedgerows.
